M109A6
Paladin...

Rifle Bracket Interference?

Stryker...

STEP LIGHTLY AROUND RESERVOIR

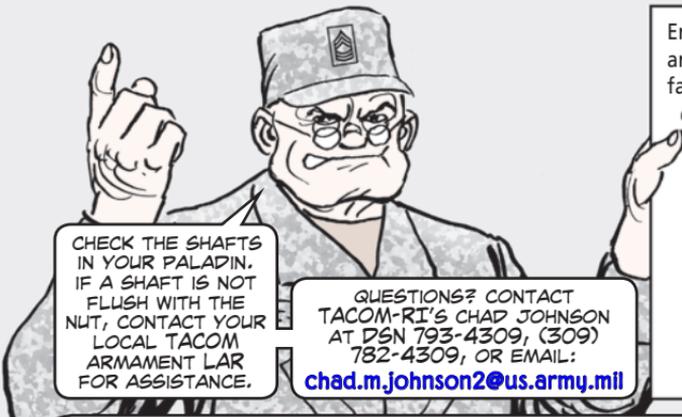
MWO 9-2350-314-30-5 REPLACED THE SHAFT FOR THE M109A6 PALADIN'S M16 RIFLE/M4 CARBINE BRACKETS. UNFORTUNATELY, SOME OF THE SHAFT NUTS WERE SCREWED DOWN TOO FAR.

AS A RESULT, THE SHAFT IS NOT FLUSH WITH THE NUT AND IT INTERFERES WITH THE EXCALIBUR ROUNDS IN THEIR RACKS.

Ensure ends of rods are flush with face of nuts

CHECK THE SHAFTS IN YOUR PALADIN. IF A SHAFT IS NOT FLUSH WITH THE NUT, CONTACT YOUR LOCAL TACOM ARMAMENT LAR FOR ASSISTANCE.

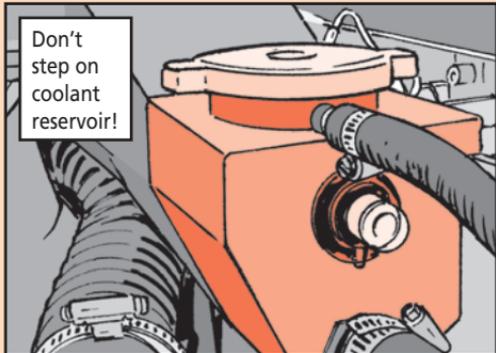
Be especially careful of the coolant reservoir. It can't hold your weight. You may not see any obvious damage, but the inner seal can crack. That sends all the coolant to the overflow tank, resulting in an overheated engine.

Don't step on coolant reservoir!

Crewmen, watch your step when you're pulling the air filter on your Stryker for cleaning. If you put those big size 12s in the wrong place, damage is sure to follow.
