OH-58D...

LOOKS LIKE YOU NEED A RUBBER PAD!

HONEYCOMB PANEL NEEDS PROTECTION

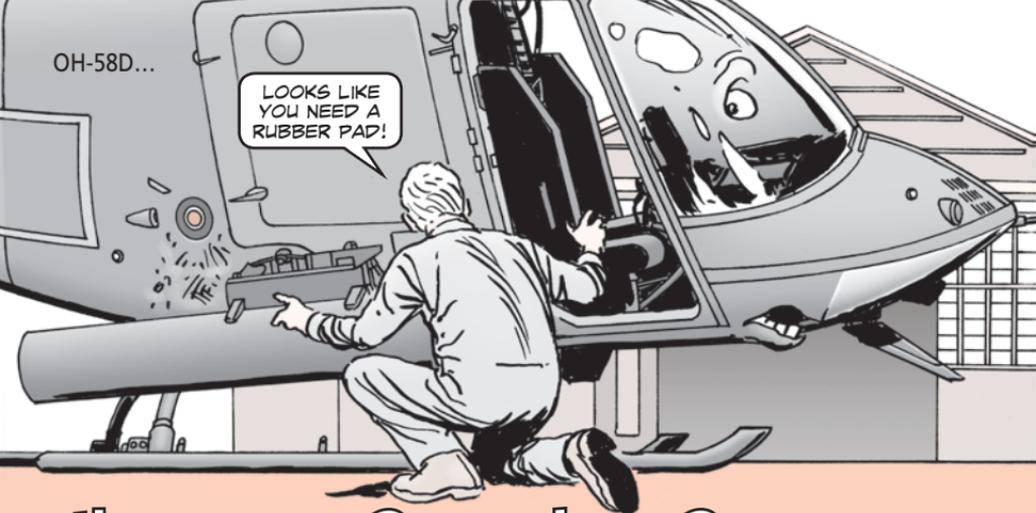
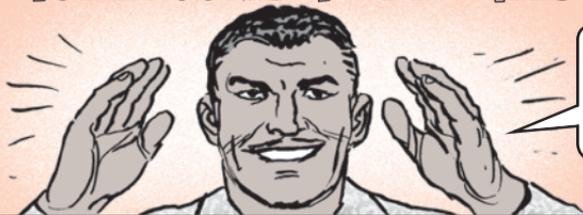
ATTENTION, MECHANICS. CRACKS, SCARS AND SCRATCHES TO THE OH-58'S HONEYCOMB PANEL COME FROM FUEL NOZZLE OR FILLER CAP HITS DURING REFUELING.

There's a rubber pad, NSN 9320-00-074-3105, that partially protects the honeycomb. But it's not strong enough to withstand the impact of the cap or fuel nozzle.

So avoid letting the cap or nozzle hit the rubber pad and you won't have to fix the honeycomb panel later. If your Kiowa Warrior does not have a rubber pad installed, make sure you install one.

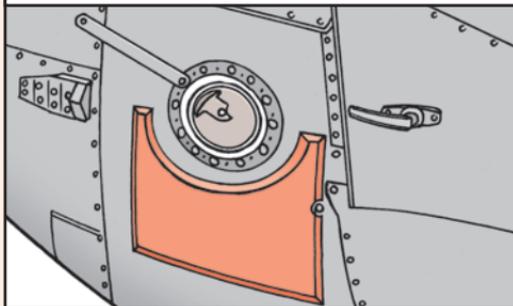
If the honeycomb behind the rubber pad looks like a woodpecker's been hammering away at it, clean, inspect and repair minor damage like it says in Task 2-2-80 and 2-2-81 of TM 1-1520-248-23, EM 0246.

Remove the rubber pad, repair the honeycomb and install a new rubber pad like it says in task 2-2-98 of TM 1-1520-248-23, EM 0246.

Repair minor damage. Replace if repair can't be done
