Missing Cartridge O-ring Seals

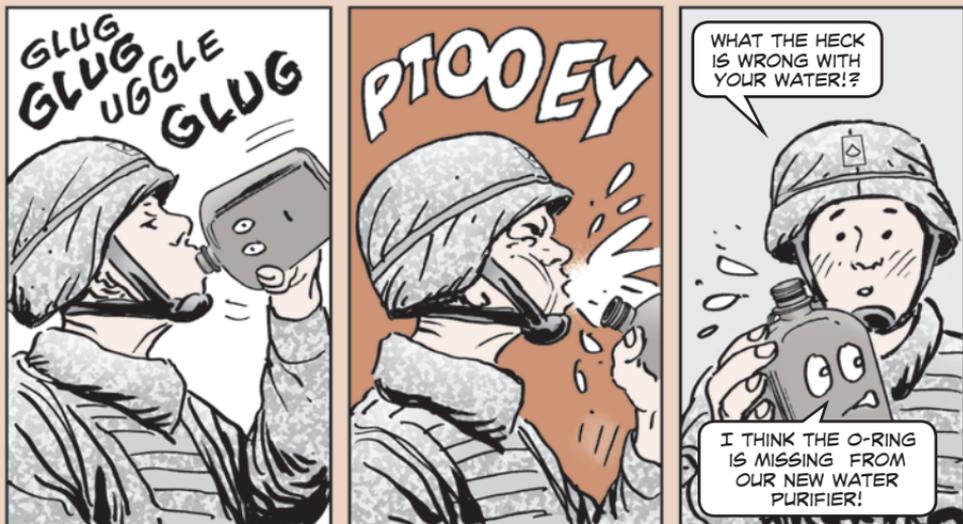
Word around the tool bench is that some of the lightweight water purifiers (LWP) were fielded with the O-ring seals missing from the purifier's reverse osmosis (RO) filter element cartridges.

You'll know something's up if the product water flow is through the roof and the RO pressure is way too low!

Without the O-ring in place, feed (source) water bypasses the RO element cartridges. The bottom line is unfiltered water that ends up in your stomach. Yuk!

Play it safe. Remove the end caps from the plugged ends of **all** seven RO pressure vessels. Work Package 45 of TM 10-4610-310-13 shows how.

Is an O-ring missing? If so, get a new one using NSN 5331-00-250-0221, shown as Item 27 in Fig 21 of TM 10-4610-310-23P.
