M198 Towed
Howitzer...

MISSING PIN A PROBLEM

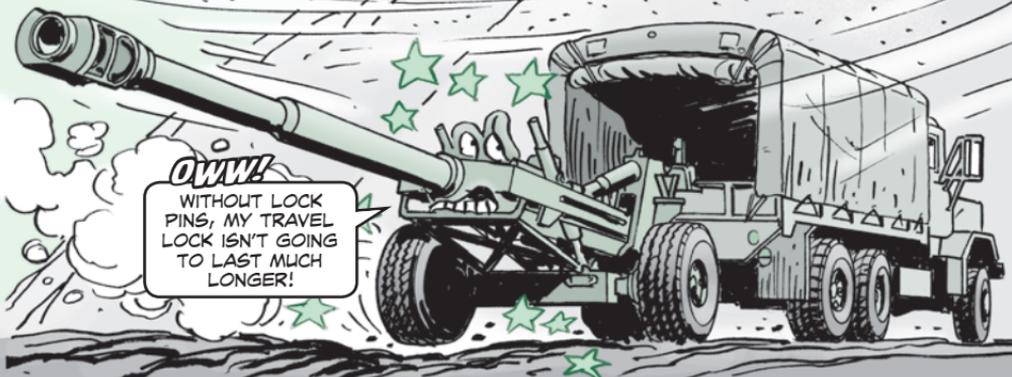
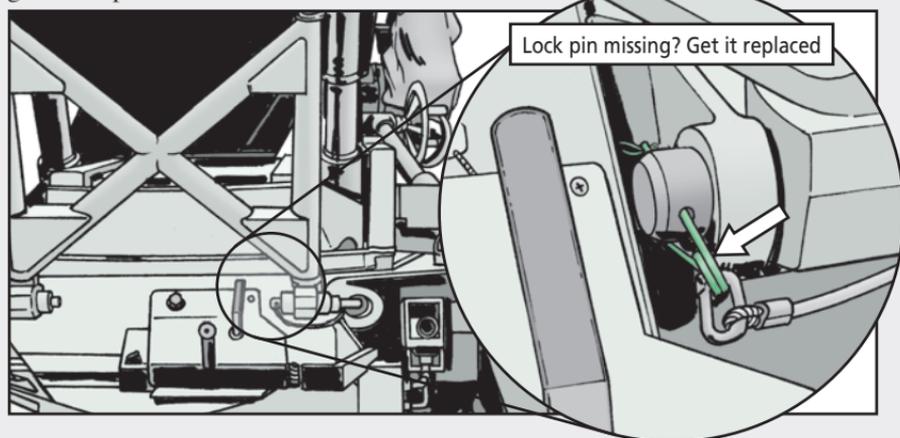
Unfortunately, the lock pin, NSN 5315-01-032-7107, is sometimes missing. It's normally attached to the pin assembly by a wire rope, NSN 4010-00-829-6321, but can sometimes get snapped off by brush during cross-country travel.

Don't try to use either pin assembly to hold the travel lock in place without their lock pins. No lock pin means the manual control handle, NSN 5340-01-046-4757, can vibrate loose during towing. If one or both handles fall out, the travel lock can be damaged or even sheared off.

So, take a look at the travel lock pin assemblies during PMCS. If parts are missing, get 'em replaced.
