HMMWV...

# OIL COOLER FAILURE DEAD-LINES TRUCK!

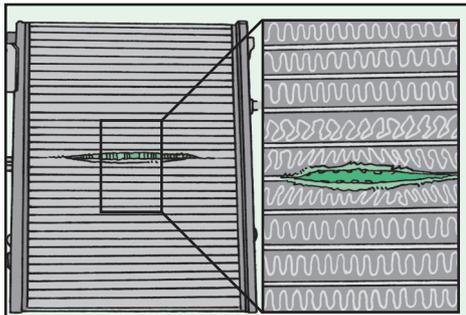
These tubes could expand or rupture during initial engine warm-up or start-up, especially when the vehicle's hydraulic system is cold. A ruptured power steering cooler causes a loss of power steering fluid and pressure, making your HMMWV hard to steer. Braking will also suffer because the power hydro-boost is also affected. You don't need hard steering or braking, especially in a war zone!

Failure example: Ruptured power steering flow tube

If you find a faulty oil cooler, your HMMWV is NMC! And it'll stay that way until the combination oil cooler is replaced. By the way, an oil cooler relief valve retrofit kit has been developed to prevent premature failure of the combination oil cooler. But your HMMWV isn't NMC if this retrofit kit is not installed.
