# Loose Cable Like a DAGR in the Back

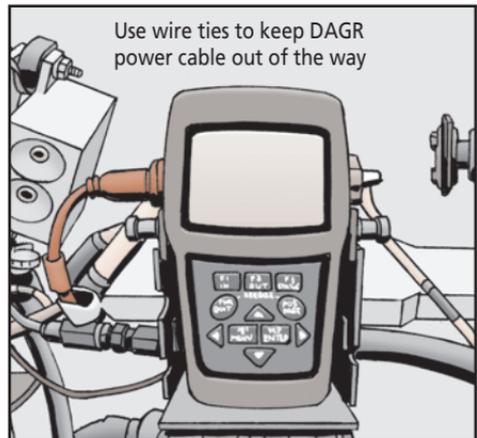
Problem is, that darn 1W106A-7 DAGR power cable, NSN 6150-01-557-4006, keeps getting in the way, especially if you're wearing body armor. Once snagged, the cable gets jerked loose or damaged. Then you lose power to the DAGR.

When installing the DAGR, make sure the power cable is fitted into its storage slots. Then use some plastic wire ties, like NSN 5975-00-111-3208, to hold any drooping cable out of the way.
