Get New Decal for Straight Scoop

FM 3-20.21 Note

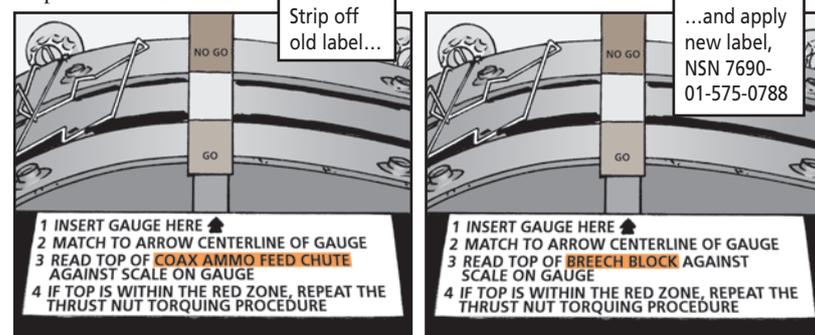
The main gun recoil piston sleeve position check starting on Page A-72 of FM 3-20.21 (Sep 09), *Heavy Brigade Combat Team (HBCT) Gunnery*, still contains the incorrect information on how to perform the GO/NO GO check. Until the FM is updated, do a pen and ink change. Change all **coax ammo feed chute** references in Step 4 to **breech block**.

Mechanics, the semiannual gun mount assembly GO/NO GO check is crucial. If you don't do it, or do it wrong, main gun accuracy degrades until it becomes difficult to hit a target.

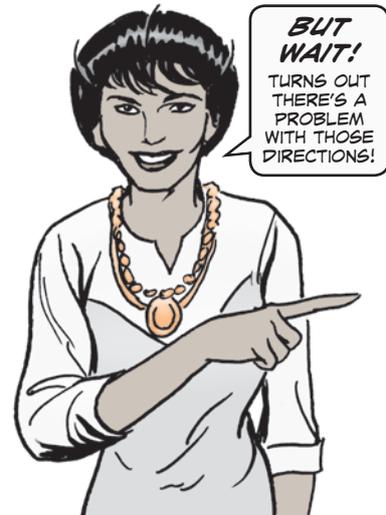
Step 3 on the decal says to read the **top of the coax ammo feed chute** against the scale on the gauge. Problem is, warping and bending of the ammo feed chute can result in a bad measurement. So the procedure has been amended to read the **top of the breech-ring** against the gauge instead.

The correct instructions are on Page 2-32 of TM 9-2350-264-20-2-1 (Apr 03) and WP 0258-22 of TM 9-2350-388-23-2-2 (Jan 09). But most mechanics just follow the decal and get a wrong reading.

A new decal, NSN 7690-01-575-0788, is now available with the correct instructions. So strip off the old decal and apply the new, stick-on label in its place.

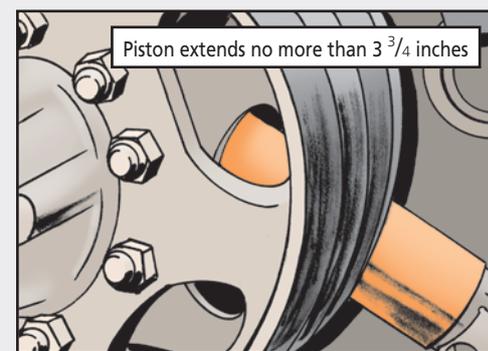
When tightening the track, the maximum extension for the piston is 3 ³/₄ inches. If you try to tighten any more than that, excess grease is bled off through a small hole in the piston. You're just wasting grease because the track won't get any tighter.

If you see grease coming out of the bleed hole and the track is still too loose, bleed off the track adjuster to loosen the track and remove a shoe. Then try again.
