# REAR SUSPENSION CRACKS SET YOU BACK!

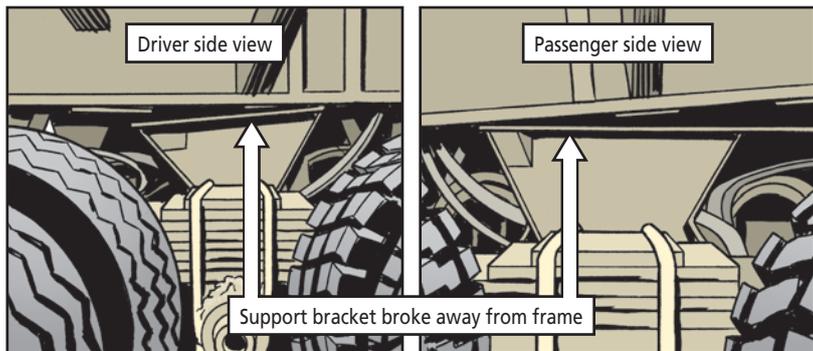
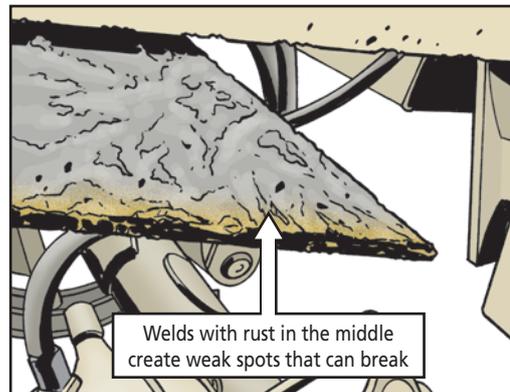
TACOM SOUM 10-017 told commanders to have all M871 and M871A1 semitrailer trunnion mount brackets inspected at the frame weld area for cracks and/or separations using TB 9-2510-242-40 as a guide. That's because cracks have been found in the trunnion mount bracket assembly area that attaches the suspension and the axle to the frame. In fact, the welds on some semitrailers are *completely* cracked, separating the trunnion from the frame. This could lead to complete separation of the rear suspension and axle from the semitrailer!

By the way, a trunnion mount inspection is now part of the crew/operator's BEFORE PMCS. Pencil in this change to TM 9-2330-358-14&P.

Don't repair cracks if you find them because the M871 & M871A1 semitrailers are on the automatic disposal list. Just turn your unserviceable semitrailers in to DLA Disposition Services (formerly called the Defense Reutilization and Marketing Office or DRMO). Then order a replacement, if authorized by your unit's TOE.
