REVISIT COMMUNICATION CORD PROBLEM

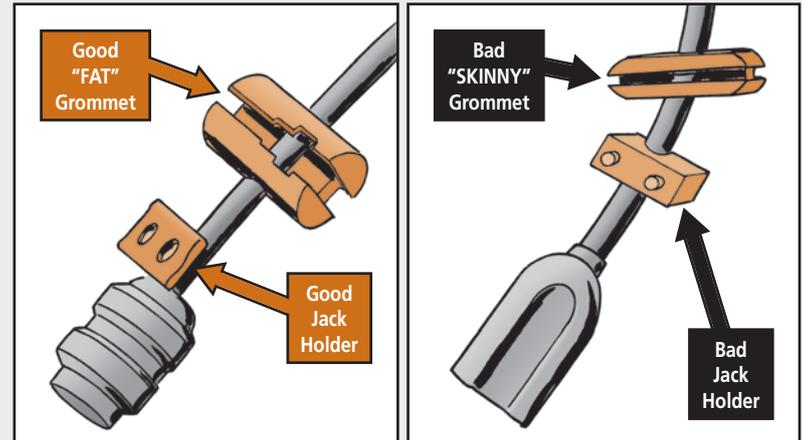
We forgot to tell you that there was a new problem with the communication cord that developed after the first lot. In 2008, DLA stopped purchasing the communication cords directly from Gentex and began to purchase cords directly from several aftermarket manufacturers whose CAGE codes are: 38LK9, 305Q5, and 7Z016. Units started submitting PQDRs against the aftermarket manufacturers in May of 2010. The problems with these aftermarket communications cords involve problems with loose and sloppy over-braiding, cold solder joints, and the failure to use parts called out on the drawing that can be seen in the picture below.

DLA was able to freeze internal stocks of these aftermarket communications cords so no more bad ones would hit the field. Future procurement will be from Gentex.

If your readers have any bad cords marked with cage code 38LK9, 305Q5, and 7Z016 in their ALSE shop, they should not send them back to Gentex. To get credit for any bad cords, they must submit a PQDR like it says in AR 702-7-1, *Reporting of Product Quality Deficiencies Within the U.S. Army*.

To order the correct electrical branched cord assembly for their helmets, they should use NSN 5995-01-519-9234 (P/N 1680-ALSE-410-1).
