SHOOT DOWN CROWS PROBLEMS!

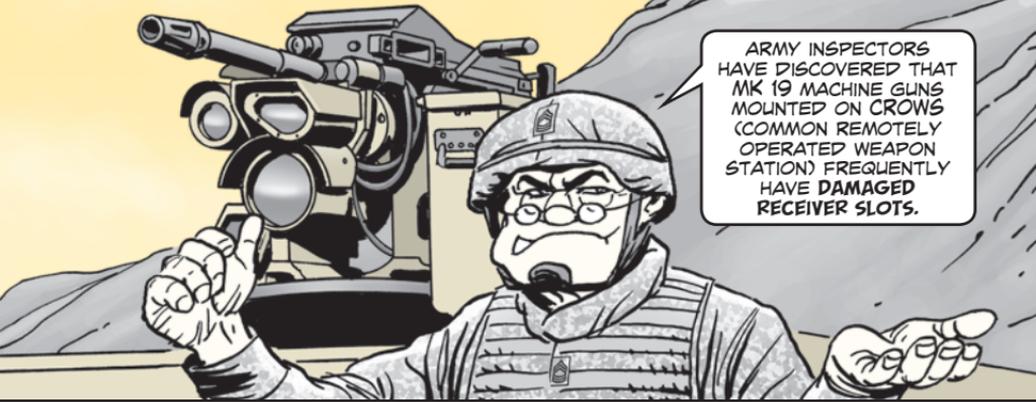
The damage is caused by the cocking actuator bracket lever not being fully engaged in the left side of the receiver slot. If the lever's not fully engaged and not electronically charged, the lever doesn't make contact with the bolt. Then the cocking actuator bracket lever drags the full length of the receiver slot. Often the MK 19 must be coded out.

- Do the PMCS in the MK 19's TM 9-1010-230-10 before you mount the gun. Also lube it. All the PMCS and lubing instructions are in WP 0010.
- When installing the MK 19 on CROWS, carefully follow the instructions in WP 0016 of the CROWS' TM 9-1090-219-10.
- Make sure the cocking actuator bracket lever is fully engaged so that the charger hook can't score the receiver as the lever moves back and forth.
- If the cocking actuator lever doesn't fully engage or the cocking actuator arm slot isn't parallel to the mount so that the cocking bracket can seat properly, repeat the instructions in WP 0016.
- If that doesn't cure the misalignment, tell your repairman. Something is wrong.
