M95 Mortar Fire Control System...

# CHECK FOR BAD CABLE

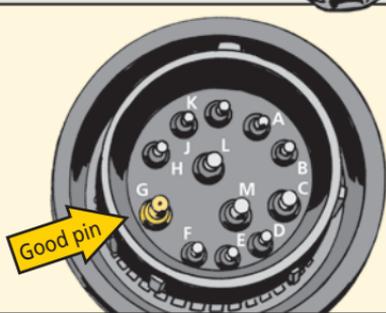
THE PROBLEM IS THE **WRONG G PIN** WAS INSTALLED IN THE PI CONNECTOR. THE CORRECT G PIN IS **COAXIAL, NOT SOLID.**

Check 35W9 cables...

...for coaxial G pin. If it's solid, cable is bad

So immediately check all your 35W9 cables, including those in supply stock, for the wrong G pin. If it's solid, it's wrong. Also check any 3W9, 3W2, and 55W7 cables that may have been connected to the 35W9 for damaged pins.

If you find any, isolate the cable and file a Product Quality Deficiency Report (PQDR) with the Product Data Reporting and Evaluation Program (PDREP):
