MRAP GUNNER'S HATCH LATCH PIN

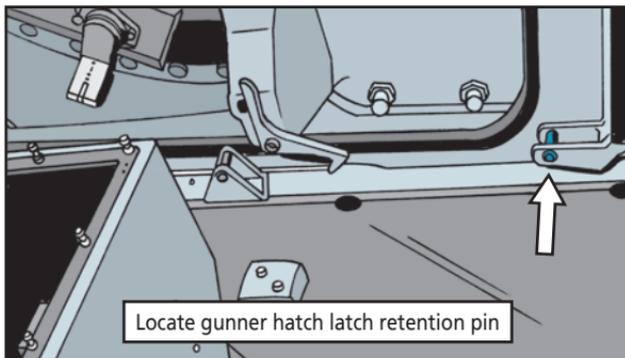
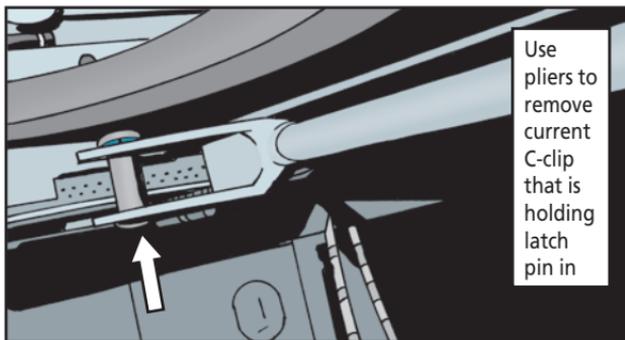
The gunner's sliding hatch inner lock assembly latch pin on the MRAP MaxxProPlus is falling out of place because of a faulty C-clip. That means the hatch can slam down without warning on the gunner! Refer to WP 4-14.4 of TM 9-2355-318-23-3 on how to remove the C-clip, Item 9, and the latch pin, Item 10, and how to replace them with retrofit latch and cotter pins. See TACOM GPA 09-020 for more info:
