Stryker...

PUT A STOP TO BRAKE DRUM STRIPPING!

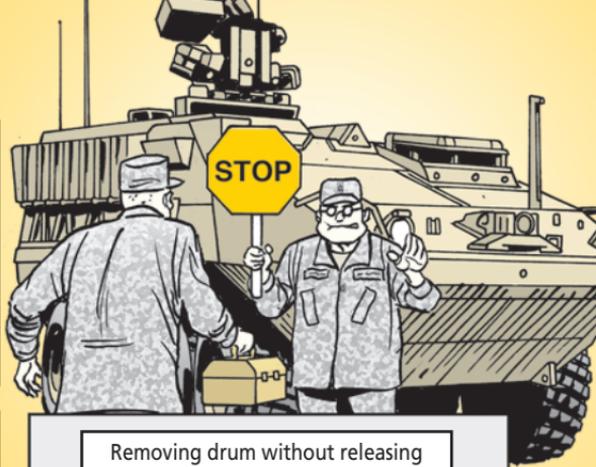
Recently, we've received reports that some Stryker brake drums are having to be replaced because of stripped jack bolt holes. Jack bolts are used to help remove the drum during PMCS inspection when it's stuck in place.

One possibility for the stripped holes is that technicians may be trying to remove the drum without first releasing the brake shoes. The brake drum replacement procedures in the IETM are being revised to make this requirement a little more clear.

Removing drum without releasing brake pads could strip jack bolt holes

Until that happens, can you remind them that the brake shoes should always be released before trying to remove the brake drum?
