WINNING THE GREAT *BREECH RUST* DEBATE

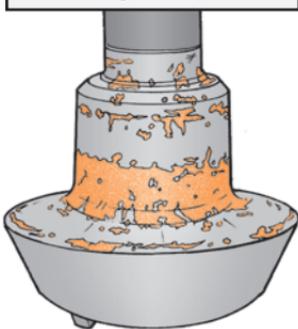
We've been having a lot of trouble lately with breech corrosion on our M777A2 towed howitzers. Specifically, the spindle and obturator pad are turning up coated with rust!

If not removed for cleaning and lubing, both spindle...

...and obturator pad will rust

In this case, you win the argument, Sergeant! While the TM doesn't specifically tell you to remove the spindle and obturator pad for cleaning, that is what was intended. In fact, the TM is scheduled to add removal of the components for cleaning and lubing at the next update.
