BURST BRAKES A REAL BUMMER

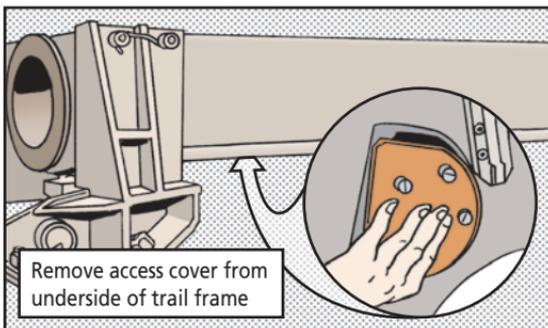
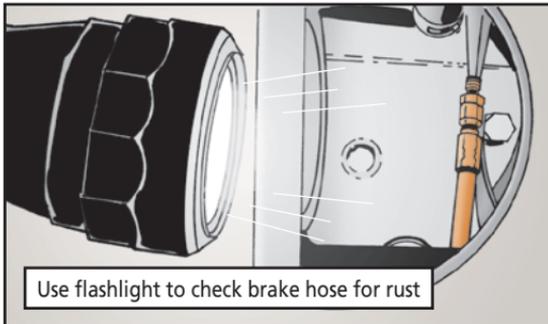
While performing scheduled services, we've noticed that the M119A2's brake hose, NSN 4720-01-344-6034, is badly rusted about 80 percent of the time. Those rusty hoses can easily burst during brake tests and normal operation.

The brake hose is easy to reach. Just open the right-hand (curbside) access cover, PN 12591232, on the underside of the trail frame. Then use a flashlight to look at the brake hose inside the frame chamber. If it's rusty, get the brake hose replaced right away.

We recommend that operators keep a close eye on this brake hose and that it also be checked during every service. It's also a good idea to make sure the drain plugs, NSN 5365-01-488-7429, and access cover gasket, NSN 9320-01-343-1778, are in good condition.

Editor's note: An excellent suggestion, gentlemen. The procedure for replacing the brake hose is in WP 0045 00 of TM 9-1015-252-34 (Aug 06, w/Ch 1, Feb 08).
