Move BFT Connector or Lose it!

HERE'S YOUR
CHANCE TO FIX
ONE OF THOSE
PROBLEMS ON
THE M1A2 SEP.

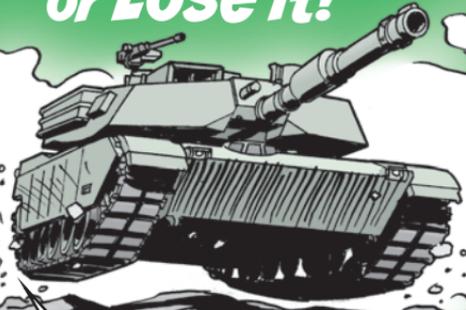
The 1W102-7 P8 connector for the Blue Force Tracker (BFT) system is mounted to the turret roof next to the gunner's dome light. That puts it right smack in the way of the recoil path of the main gun when it's fired at maximum depression.

The 1W102-7 P8 connector bracket is being redesigned to eliminate this interference. But until that happens, you'll need to move the connector out of harm's way. Here's how:
