FIREFINDER HELP FROM THE EXPERTS

AN/TPQ-36(V10)

AN/TPQ-37(V9)

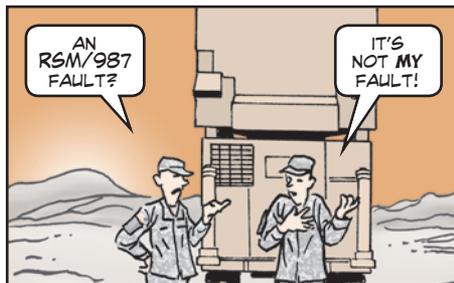
RSM/987 fault: Version 10 sometimes gets an RSM/987 fault. Don't waste time doing receiver/excitor troubleshooting to eliminate the fault. First run the 240 subtest in the shelter FIT three times with the fault bypass on. That usually gets rid of the fault. If it doesn't, then troubleshoot the receiver/excitor.

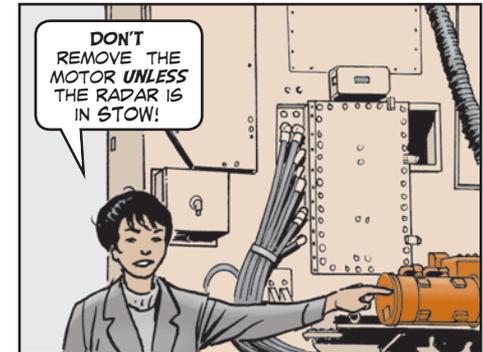
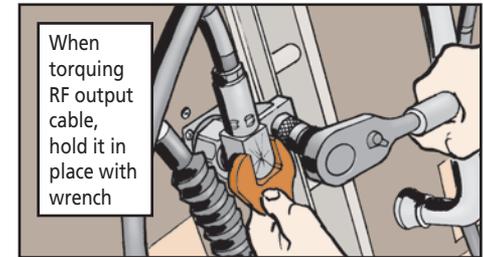
Power amplifier cable: The RF output cable must be torqued to 21 lb-ft. But as you use the torque wrench, you must hold the connector in place with a second wrench. Otherwise, the cable twists and its wiring is ruined. That can also lead to RF leakage. Do this when torquing either end of the blue cable.
