BREECH SWABBING WARNING

AN INCIDENT
INVOLVING
ACCIDENTAL
PROPELLANT
IGNITION
DURING AN
M777A2
HOWITZER FIRE
MISSION HAS
RESULTED IN
SOME **CHANGES**
TO PARA 2-30
OF TM
9-1025-215-10
(MAY 10, W/CH
1, FEB 11).

M60A1 AVLB R&classification

THE MLC FOR
FULLY MISSION
CAPABLE BRIDGES
HAS CHANGED FROM
70 TO 85!

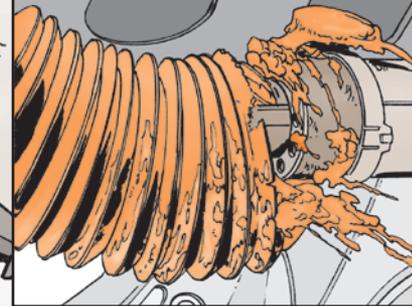
Forgetting to swab bore after each round can ignite propellant and damage equipment

Crewman must swab the bore after each round fired to clear chamber of hot embers. Failure to swab the bore after each round fired may cause explosion or fire outside the breech area and cause injury or death to personnel and damage equipment.

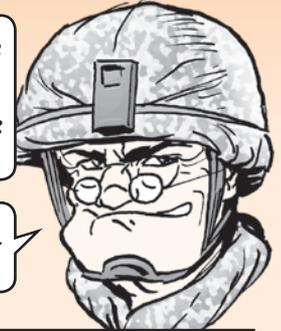
HERE ARE
FOUR OTHER
CHANGES
YOU NEED
TO MAKE
RIGHT AFTER
THE NEW
WARNING.

1. Change Step 30 to: Cannoneer No. 2 swabs powder chamber, spindle assembly, and gas check seat using chamber swab (30) after each round fired.
2. Change Step 31 to: Driver inspects cannon tube (31) and will announce BORE CLEAR after the last round of the mission.
3. Delete Step 32.
4. Renumber Step 33 as Step 32.

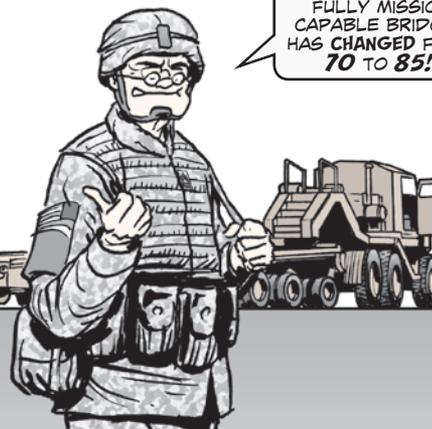
The military load classification (MLC) for the armored vehicle launched bridge (AVLB) has changed.

Follow the PMCS in TM 5-2420-203-24 to completely inspect the bridge. If the bridge is fully mission capable, you can change the stencil marking in four places on the side of the bridge from 70 to 85, and the numbers on the load-disk assemblies from 70 to 85.

The numbers on the load-disk are black, 5 inches tall and on a yellow background.
