# NOSECUP PARTS REVERSED

# Opening BAWs Manually

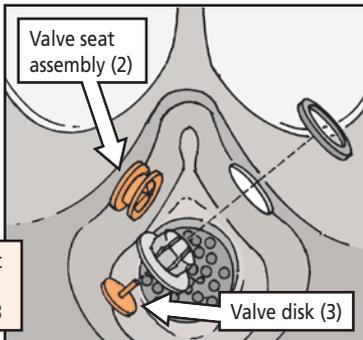
I noticed in the M40/M42 mask's TM 3-4240-346-23&P (Aug 10), the nosecup valve disk and the nosecup valve seat assembly are reversed in both Fig 2 and Fig 4 of WP 0031. The valve seat assembly is actually Item 2 in both figures and the valve disk is Item 3. I've submitted a DA Form 2028, but CBRN specialists might want to correct their TMs in the meantime.

Nosecup valve seat assembly is Item 2.  
Valve disk is Item 3

*Editor's note: Good eye, Master Sergeant. CBRN specialists, make a note of this correction to save yourself parts confusion.*

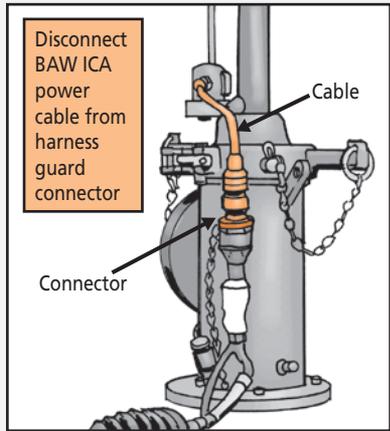
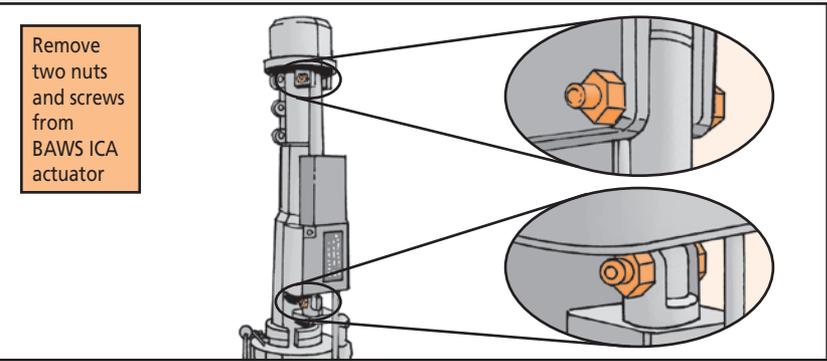
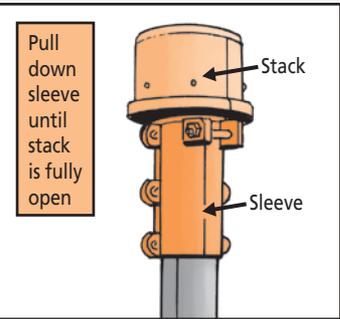
IF THERE IS A FAILED ELECTRONIC ACTUATOR WHILE OPERATING THE NBC RECONNAISSANCE VEHICLE (NBCRV), YOU **MUST MANUALLY OPEN** THE BIOLOGICAL AGENT WARNING SENSOR (BAWS) INTAKE CLOSURE ASSEMBLY (ICA).

UNFORTUNATELY, THE NBCRV'S TM DOESN'T EXPLAIN HOW. TURN THE PAGE TO FIND OUT!

- Disconnect the BAWs ICA power cable from the harness guard connector.
- Put the protective cap on the connector.
- Use a cross-tip screwdriver and a 7/16 box-and-open-end wrench to remove the two nuts and screws from the BAWs ICA actuator.
- Remove the actuator from the BAWs ICA stack and put it in stowage.
- Reinstall the two screws and two nuts on the BAWs ICA stack.
- Pull down the sleeve of the stack until the stack is fully open.
- Continue the mission and notify field maintenance as soon as possible.
