M777A2
Towed
Howitzer...

KEEP TOWING LUNETETTE TIGHT

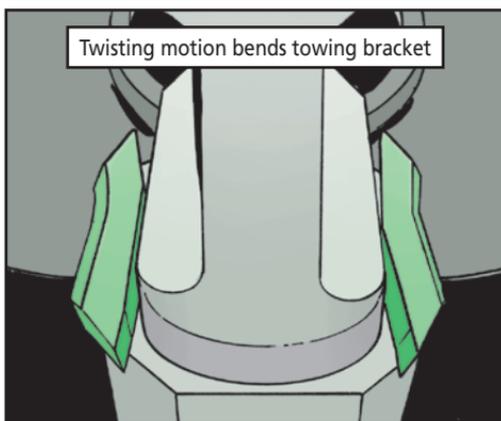
A LOOSE LUNETETTE ON YOUR M777A2 HOWITZER'S MUZZLE BRAKE CAN CAUSE NO END OF PROBLEMS!

If the lunette isn't tightened down properly, it allows a twisting motion during towing. It doesn't take too much twisting to damage the muzzle brake's tow bracket. The fix requires a depot-level welding and re-machining of the bracket.

You can prevent that expensive damage by making sure both the washer, NSN 5365-01-528-9349, and long nut, NSN 5310-01-528-9347, are in place. Then keep the long nut torqued to 350 lb-ft.
