TOO TIGHT IS TOO MUCH!

Mechanics, the AN/APR-39 radar warning antenna connectors and receivers in your helicopters shouldn't be as tight as can be.

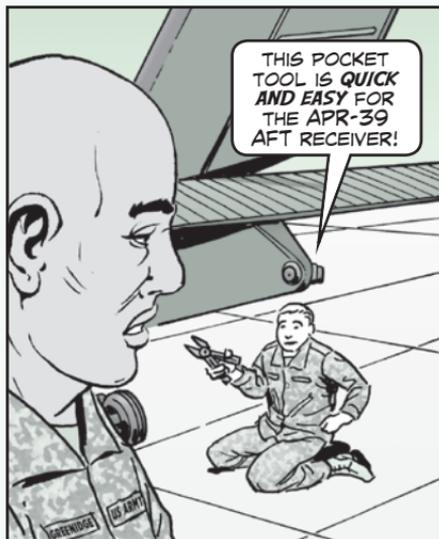
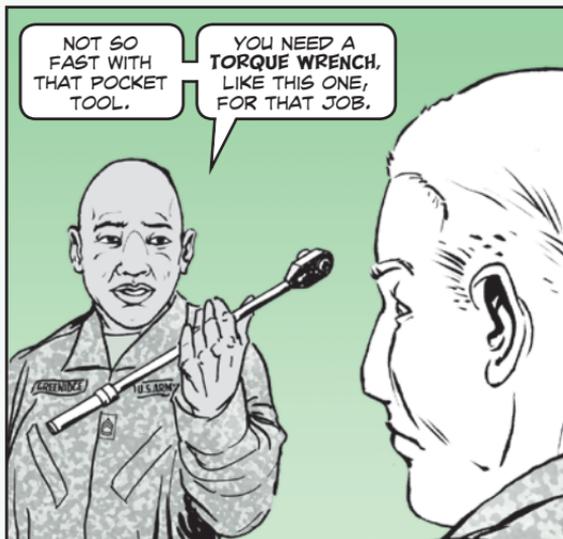
It doesn't matter what aircraft you're working on, these connectors and receivers are always 8 lb-in of torque. Any more than that and you've got broken connectors and wires.

Problem is, mechanics use a pocket tool when installing connectors and usually over-tighten them. If that happens, you can kiss the connector goodbye because it **will** break, causing failures in the system.

Using the wrong tool can cause damage. Always use a torque wrench set to 8 lb-in to tighten connectors and receivers.
