POWER STEERING CAP'S A REAL MISHAP!

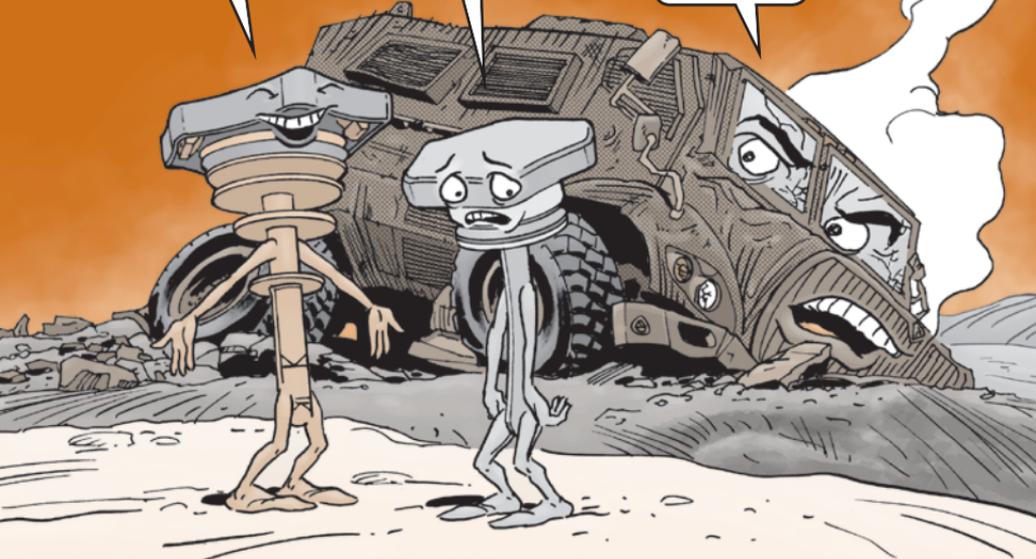
A loss of power steering fluid will cause the MaxxPro to steer hard or erratic during operation—or not at all!

The culprit is usually the vehicle's original power steering reservoir cap, NSN 2590-01-556-5316. It's a known leaker.

To stop fluid loss, replace the old cap with a new style cap. The new cap, NSN 6680-20-006-4251, has three baffles on its dipstick that keep fluid from seeping past the cap.

So eyeball the cap you have on your MaxxPro. If it's the old-style cap, replace it now.
