MRAP M-ATV...

Battery Cable Pinch

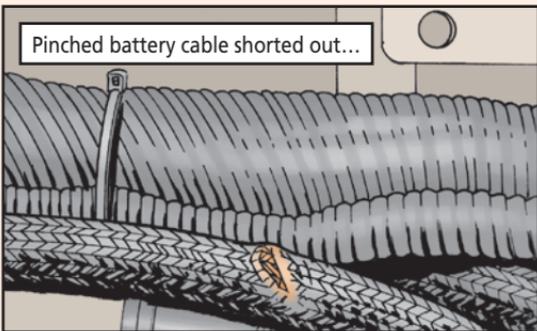
One recent fire came from a battery cable and hose clamp that were pinched against a steel plate in the transfer case area, causing an electrical short.

Pinched battery cable shorted out...

The headshed is working on a solution to stop these fires with added wire insulation or re-routing. But until they do, tell your mechanic about any chafing or damaged cables **PRONTO!**

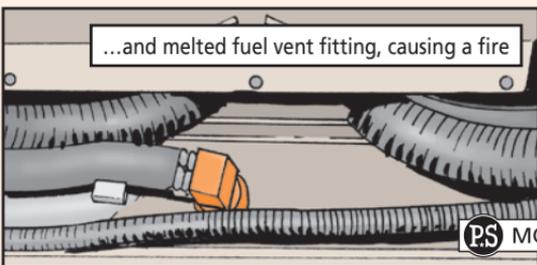
The short melted a steel vent elbow, which released and ignited fuel vapors, causing a fire beyond the reach of the vehicle's fire suppression system (FSS). That particular fire melted the engine's fuel return line and damaged all the air, fuel and electrical lines in the transfer case area forward of the fuel tank. The fire had to be put out with a hand-held fire extinguisher.

...and melted fuel vent fitting, causing a fire
