Behind the Hull

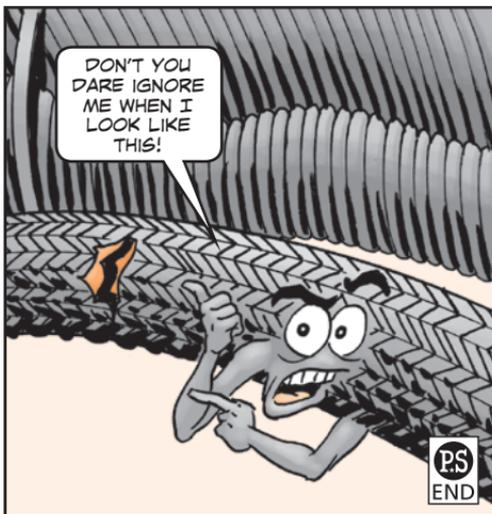
In another case, a battery cable behind the hull shorted out against the Roxtec armor cover. This fire occurred behind the hull, directly above the front of the fuel tank!

Plain and simple—a damaged or chafed battery power cable renders the M-ATV NMC.

The headshed is working on a solution to stop these fires with added wire insulation or re-routing. But until they do, tell your mechanic about any chafing or damaged cables **PRONTO!**
