STEERING COLUMN WIRING HARNESS CHANGED!

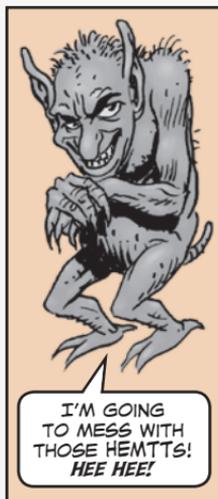
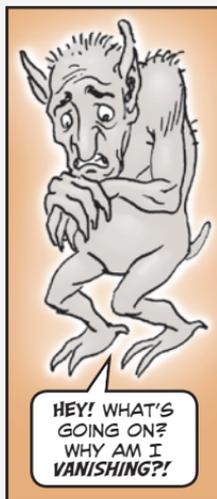
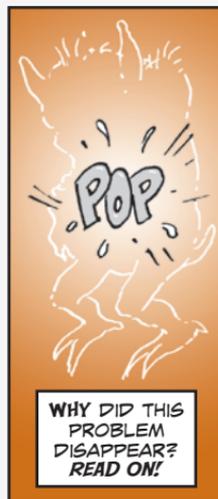
A production issue caused a cab wiring harness to rub against a grease fitting on the steering column of these HEMTT A4 and PLS A1 trucks. That contact can lead to a damaged wiring harness, including sparking of exposed wires or shearing of the wires. But the good news is, steering and other safety-related functions aren't affected.

More good news is that Oshkosh Corporation will inspect and modify suspect trucks. In fact, Oshkosh will provide the required parts and labor to correct this problem at no cost to units. The repair work will include removing and disposing of the problem grease fitting, installing a plug to fill the opening, and adding two half-inch wide cable ties.

And you shouldn't see this problem in the future because the steering shaft wiring harness change was added to HEMTT A4 and PLS A1 production on 3 Aug 12.

What about the TMs? The HEMTT A4's TM 9-2320-326-14&P (EM 0288, May 09), and the PLS A1's TM 9-2320-319-13&P (EM 0298, May 09) will be updated in the next revision. The grease fitting will be removed and two half-inch wide cable ties will be added.
