Loose Torque Rod Locknuts Cause Deadlines

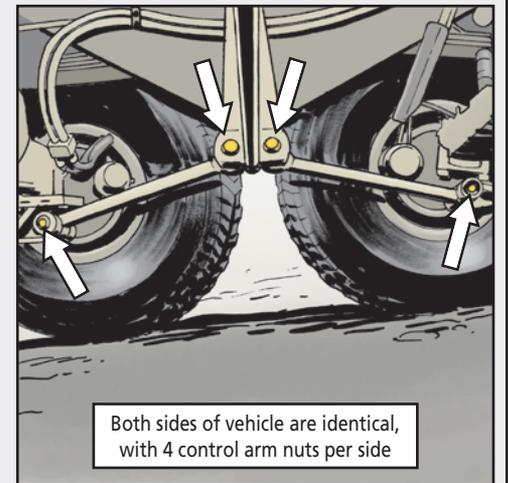
Both sides of vehicle are identical, with 4 control arm nuts per side

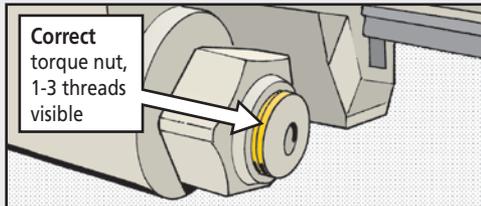
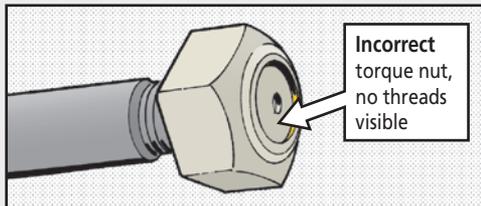
Check for Extending Threads

Immediately inspect your FMTV LTAS 6X6 truck and M1095 trailer to see if each torque rod nylon insert locknut has threads that are visible beyond the locknut. A properly tightened nylon insert locknut will show 1-3 threads exposed past the nylon lock feature.

You won't see extending threads if the locknut is improperly torqued. That means your truck or trailer is non-mission capable (NMC) until all the nylon insert locknuts have been properly torqued.
