Spindle Is Key to Tire Leak Mystery!

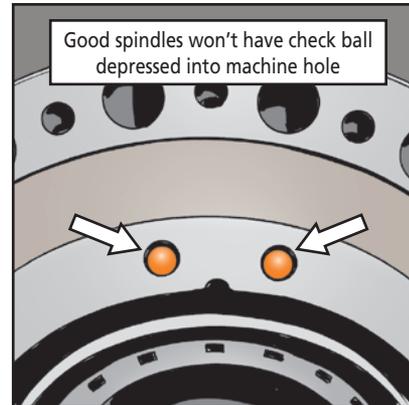
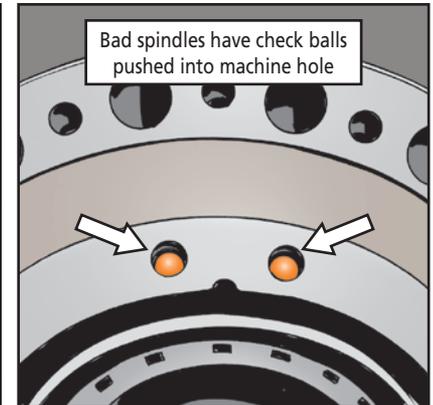
Finally, the truck's front axle was taken apart down to the spindle. We found that one of the three holes drilled on the back side of the spindle for the central tire inflation system (CTIS) had a check ball that was depressed into its machined hole. The spindle was compared to a known good one, and its check balls were *NOT* depressed into the machined holes.

We replaced the spindle on the truck and the problem was corrected.

This has happened with a few other trucks Army-wide, so your readers can save a lot of trouble by checking the spindle if they ever get a slow leak that won't go away with normal troubleshooting.
