# CORROSION COULD *DEADLINE* YOUR VEHICLE

If your unit has M967A1, M967A2, M967P1, M967A1P1, M967A2P1, M969A1, M969A2, M969A3, M969P1, M969A1P1, M969A2P1, M969A3P1, and M970A1 fuel tankers, inspect each vehicle. TACOM SOUM 13-008 gives you details on what to do. It's available at:

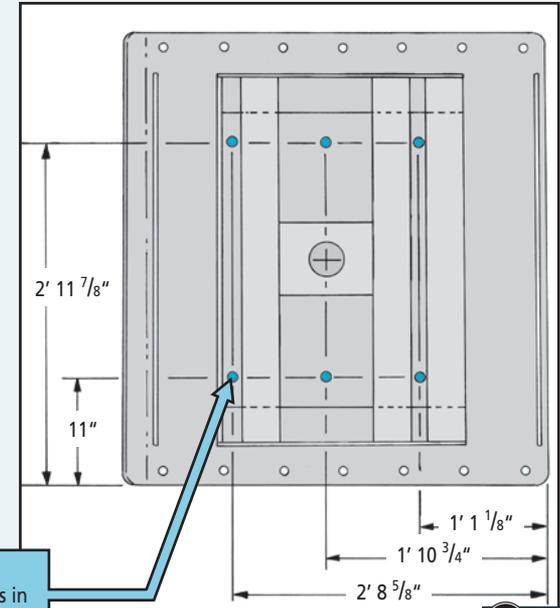
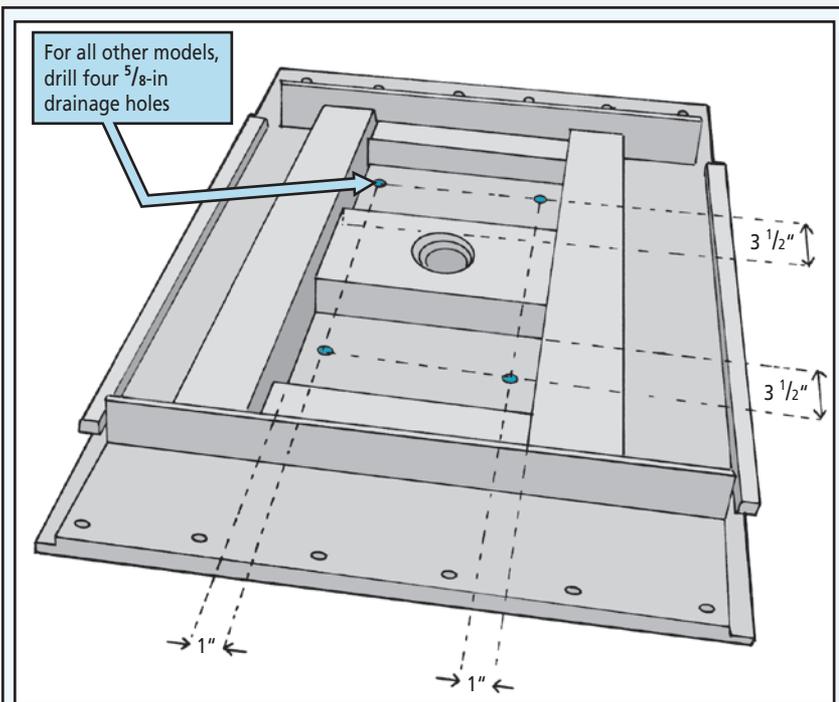
Here's where those drainage holes should be located:

For M967A2 and M969A3 models, drill six  $\frac{5}{8}$ -in holes in kingpin coupler weldment.

First, remove all corrosion and old paint. Next, treat and repaint the area following the spot painting guidance in TB 43-0242, *WD CARC Spot Painting*. Then insert drainage holes in the kingpin coupler weldment.

When you order kingpin couplers again, they will already have drain holes. So all you'll have to do is install them.

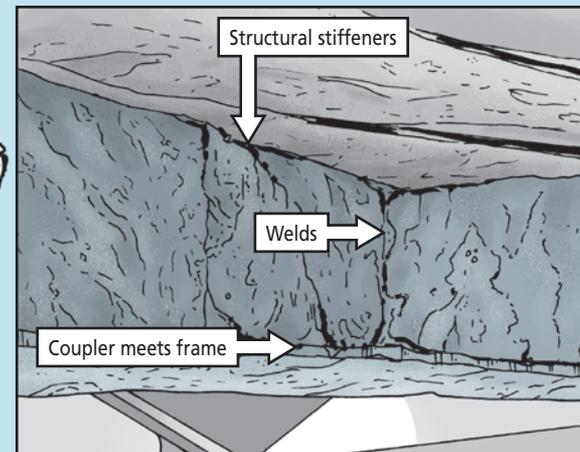
You'll find high structural stress areas at structural stiffeners, where cross members connect with frame rails, and where bottom flanges meet with the beam web and weld joints. Even if you see only a little corrosion, you should still measure these areas.

BE SURE TO INSPECT ALL HIGH STRUCTURAL STRESS AREAS!

Determine the cross-sectional thickness of the corroded area using the vernier caliper. When the overall material thickness is .213 inches or more on the frame rails and structural components, remove all corrosion and any old paint. Then treat and repaint using TB 43-0242 for guidance.

If the thickness of the frame rails and structural components is less than .213 inches, the tanker is non-mission capable until repairs are made.

Areas that measure between .125 and .212 inches on the frame rails and structural components should be reinforced to .375 inches. The rebuild will require heavier sectional members, including backing plates. Refer to Para 5-5, Repairing Deterioration Caused by Corrosion, in TB 9-2510-242-40. Section IV of the TB gives you info on the equipment and skills necessary to repair the tankers.

If the frame rails and structural components have a thickness of less than .125 inches, the entire structural section, including the frame rails, cross members and structural stiffeners, must be replaced.
