# Disconnect to Protect

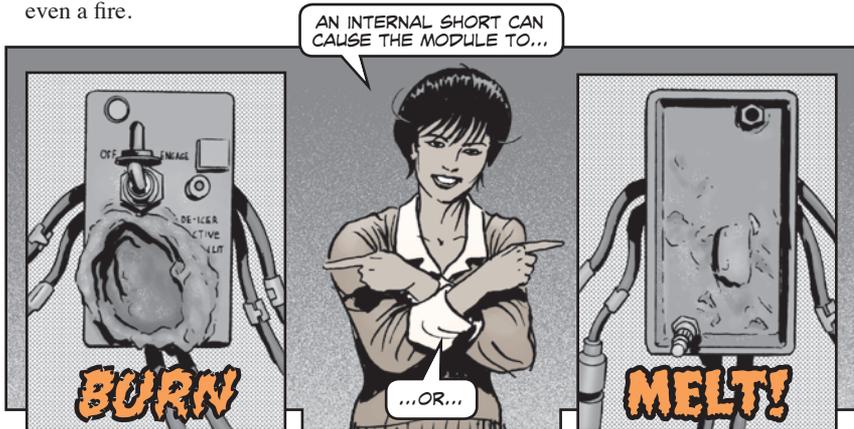
If you haven't already heard, mechanics, there's a problem with the windshield de-icer module, NSN 2540-01-560-2062, that may be installed on some up-armored HMMWVs. The culprit is a short that can result in overheating, smoke and maybe even a fire.

The short is likely caused by a transient voltage surge that occurs if the HMMWV is improperly slave started or operated with low batteries. This can happen even if the de-icer is **not** being used because the module is connected to DC power whenever the vehicle is running.
