# DON'T STEP THERE!

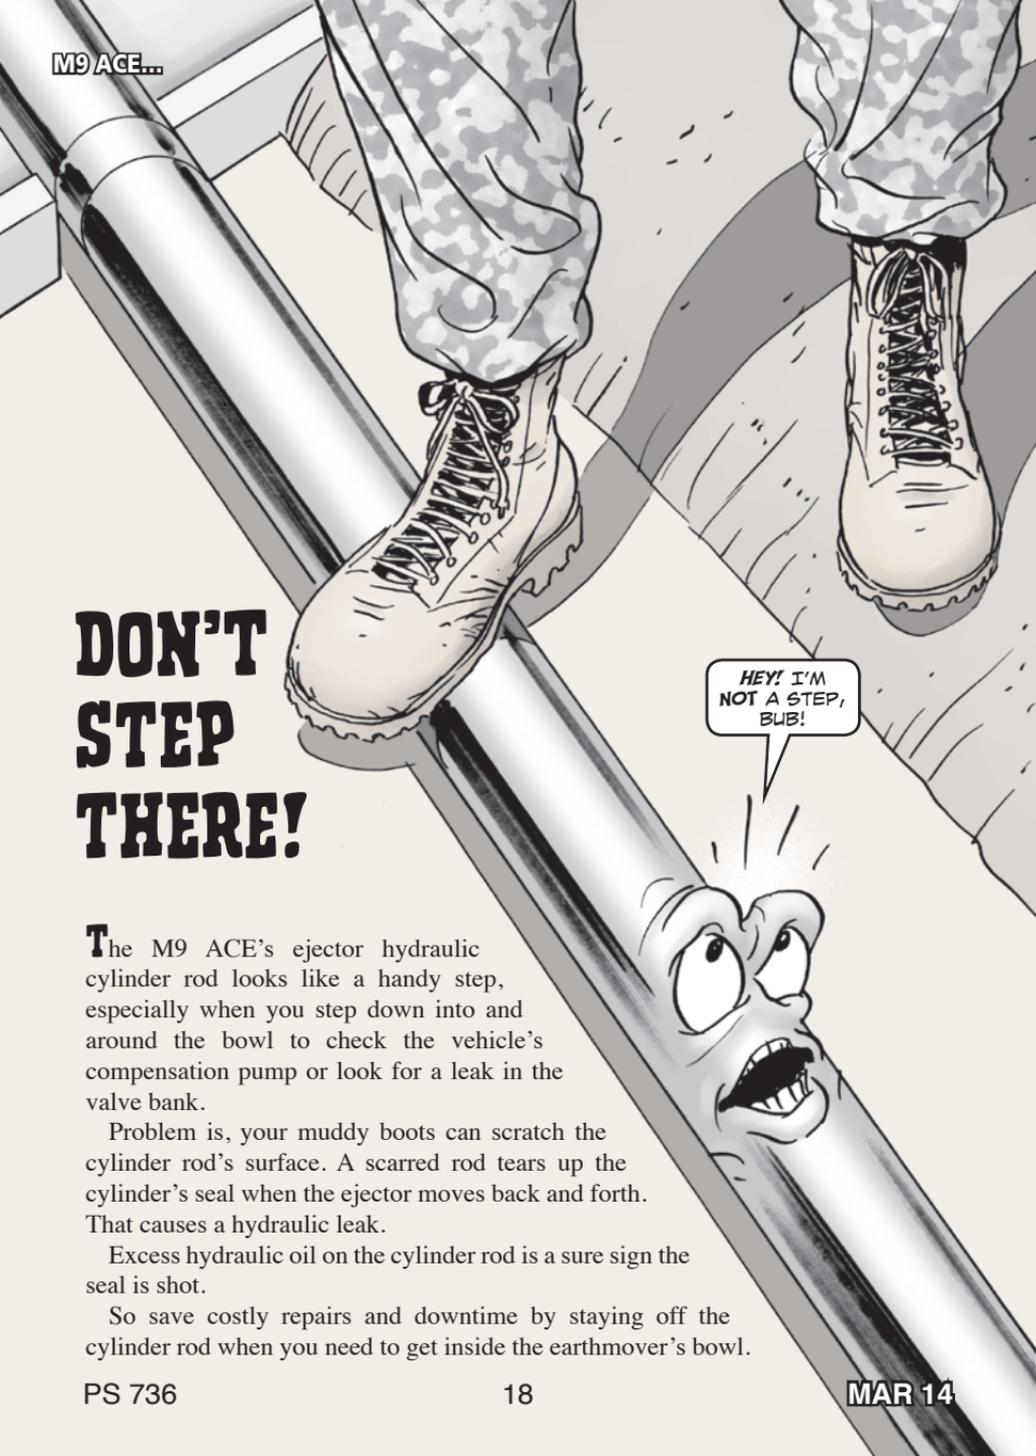
Problem is, your muddy boots can scratch the cylinder rod's surface. A scarred rod tears up the cylinder's seal when the ejector moves back and forth. That causes a hydraulic leak.

Excess hydraulic oil on the cylinder rod is a sure sign the seal is shot.

HEY! I'M  
NOT A STEP,  
BUB!

So save costly repairs and downtime by staying off the cylinder rod when you need to get inside the earthmover's bowl.
