MISROUTED WIRING WARRANTS WARRANTY

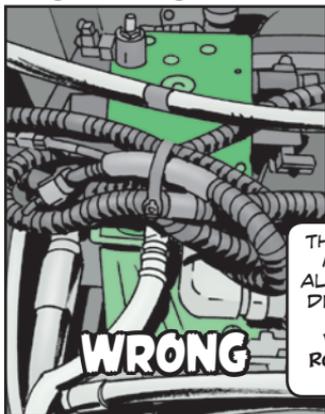
A manufacturing error resulted in the wiring harnesses being routed directly across the top of the hydraulic distribution manifold in some HEMTT -A4 trucks. Routed this way, the wiring harness might start a fire.

THE SOLUTION IS FOR YOU MECHANICS TO INSPECT ALL HEMTT -A4 HYDRAULIC DISTRIBUTION MANIFOLDS. MAKE SURE THAT NO WIRING HARNESSES ARE ROUTED OVER THE TOP OF THE MANIFOLD.

If you find any, contact Oshkosh Corporation to schedule the vehicle for repair. They're at: WarrantyClaims@defense.oshkoshcorp.com

Oshkosh will provide the required parts and labor to fix the trucks at no cost to your unit. They'll repair the vehicles as part of a retrofit effort that includes rerouting the wiring harnesses.
