M224,
M224A1
Mortar...

GET THE TORQUE RIGHT

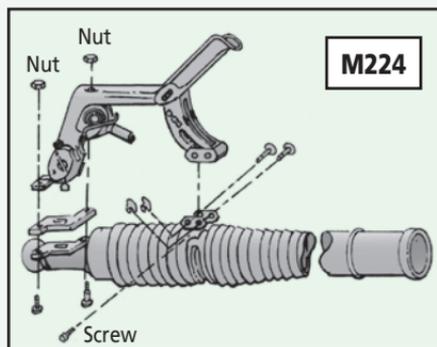
*M224: Tighten the self-locking screw and nuts to 10 + 2 lb-ft (13.6 + 2.7 N·m).

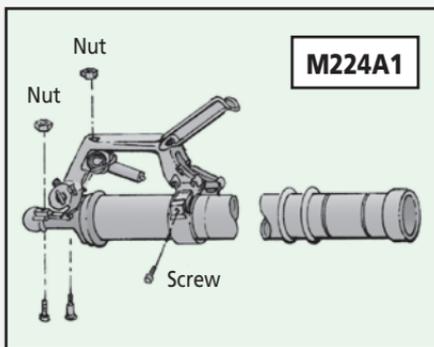
*M224A1: Torque the two new self-locking nuts to 10 + 2 lb-ft (13.6 + 2.7 N·m). Torque the shoulder screw into the loop clamp to 12.5 + 2 lb-ft (17.0 + 2.7 N·m).
