NO IMAGE? CHECK RETAINING RING

MK 19 Machine Gun...

Sear, Feed Slide SMR Codes Wrong

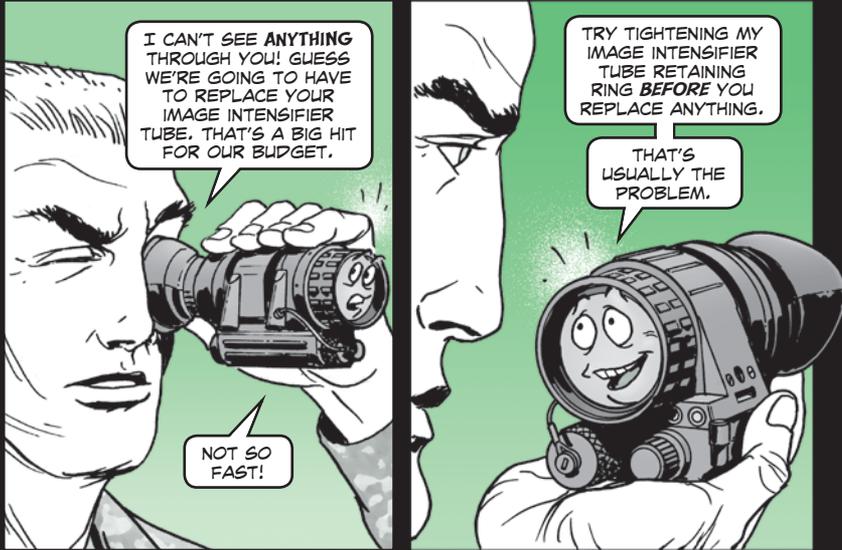
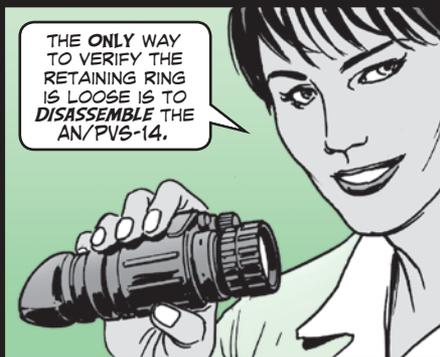
Repairmen are replacing the AN/PVS-14 night vision device's image intensifier tube when the problem may be just a loose retaining ring. That's a \$1,500 fix for a ring that just needs tightening.

When the retaining ring isn't installed right, it can loosen. That allows the light pipe and image intensifier to shift in the housing. The light pipe can no longer project the IR indicator light or low battery indicator in the field of view. That makes the AN/PVS-14 NMC.

And if the retaining ring loosens completely, the image intensifier won't work at all.

The following faults are indicators of a loose retaining ring:

- Low battery indicator doesn't light
- Image intensifier doesn't glow green
- IR illuminator fails
- IR indicator light doesn't work
- A noticeable rattle when the NVD is handled

If the problem is a loose retaining ring, remember you must use the retainer wrench, NSN 5120-01-170-5088, to tighten the ring or it won't stay tight.

The troubleshooting table in TM 11-5855-306-23&P will be revised to add a check for a loose image intensifier tube retaining ring. There will also be an enhanced maintenance training package coming out for the AN/PVS-14.

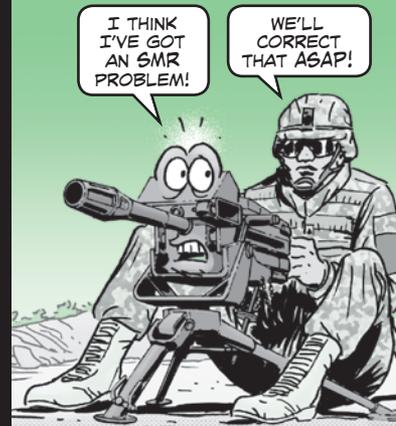
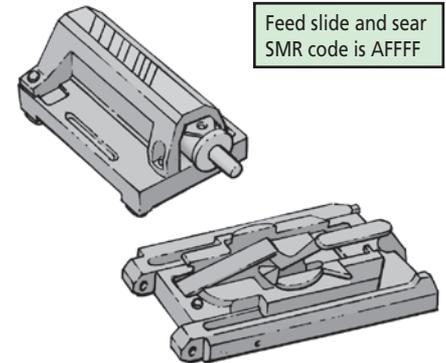
Dear Half-Mast,
We are having trouble ordering the sear assembly and feed slide assembly for our MK 19s. Fig 2 in TM 9-1010-230-23&P (Aug 12) lists NSN 1010-01-133-6990 for the sear assembly and NSN 1010-01-133-6980 for the feed slide assembly. But FED LOG shows these NSNs as unavailable. Can you help?
MSG C.T.

Dear Master Sergeant,
Sure can. The TM lists an SMR code of PAFFF for both items. That's wrong. The correct SMR code is AFFFF, which means you order the individual components and assemble them at field-level maintenance. See Fig 11 for the feed slide assembly components and Fig 12 for the sear assembly components. The SMR codes will be corrected in the next revision to the TM.
Half-Mast
