# CURE SLUGGISH FIRING

Some units are reporting that their new M2A1 machine guns are firing sluggishly. If your M2A1 just doesn't have any get-up-and-go, energize it like this:

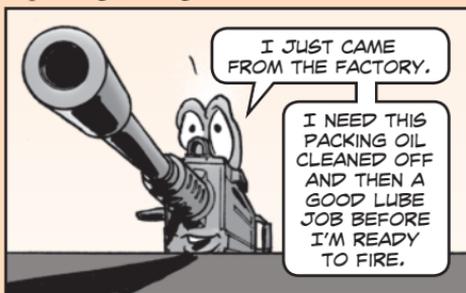
But if you've cleaned and lubed your M2A1 completely and it's still firing poorly, the problem may be that the buffer discs on the back plate are saturated. To check for this, repairmen should remove the disks following the procedure in WP 0017 of the -23&P. Replace wet disks with NSN 1005-00-515-2835.

Backplate discs saturated?  
Replace 'em!

When reassembling the back plate, make sure there's no in-and-out movement of the recoil mechanism buffer. You may need to add an extra disk if it's loose.
