BENT BRACKET CAN FREEZE UP Ruh-Ruh-Ruh-Ruh-Ruh-Ruh-Ruh-Ruh-Ruh RELAY!

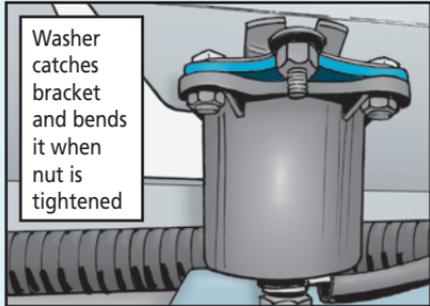
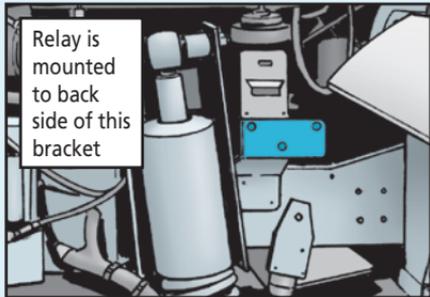
We've discovered that the auxiliary starter relay mounting brackets on some of our new M1157A1P2 10-ton dump trucks were bent at the factory.

During installation, the top washer is catching against the housing bracket. As the nut is tightened, the bracket bends upward. Unfortunately, that lets moisture inside the solid relay, NSN 2920-01-361-5802. In cold weather, the water freezes and keeps the truck from starting until the relay thaws.

Can you let folks know to keep an eye out for this problem? The auxiliary starter relay is on the left side of the engine and just to the right of the steering fluid reservoir. It's mounted to the back side of the bracket, so you'll need to stand on the tire (or a maintenance stand) and use a mirror to get a good look at the relay.

Right now, your best option is to replace the solid relay and then submit a PQDR. Submit the PQDR at: <https://www.pdrep.csd.disa.mil/>
