# The Shot Heard 'Round the Turret

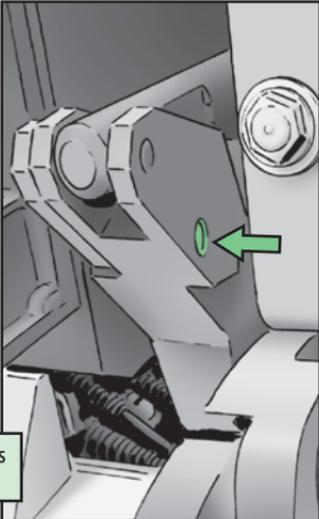
Our brigade has found a lot of bolts, NSN 5305-01-336-8241, missing from the breech crank assembly on M1-series tanks. Either the crews have been removing the bolts, which they're not supposed to do, or the bolts are coming loose and falling out on their own.

Either way, the bolt; spring, NSN 5360-12-189-0284; and nut, NSN 5310-01-336-3521, on the breech crank assembly end up missing. When that happens, the closing piston comes apart and shoots across the turret, especially during firing. That's a good way to hurt someone.

Apply sealing compound to threads of breech crank assembly bolt

Crews should check the breech crank assembly and report any bolts that are loose or missing to their mechanic. He'll apply sealing compound, NSN 8030-01-025-1692, to the bolt's threads like it says in WP 0813 of TM 9-2350-388-23-2-4 (Jan 09, w/Ch 1, Oct 11) and WP 1359 of TM 9-2350-264-23-2-6 (Jul 11, w/Ch 2, May 13). That'll keep those pins tight and our tank crews safe.

Mechanics, make sure you use the safety clip, NSN 5340-01-205-9963, to keep the piston in place while adding sealing compound to the breech crank assembly bolt. See WP 0774 in TM 9-2350-388-23-2-4 and WP 1342 in TM 9-2350-264-23-2-6 for more information.
