DON'T GET BENT UP OVER BRACKET

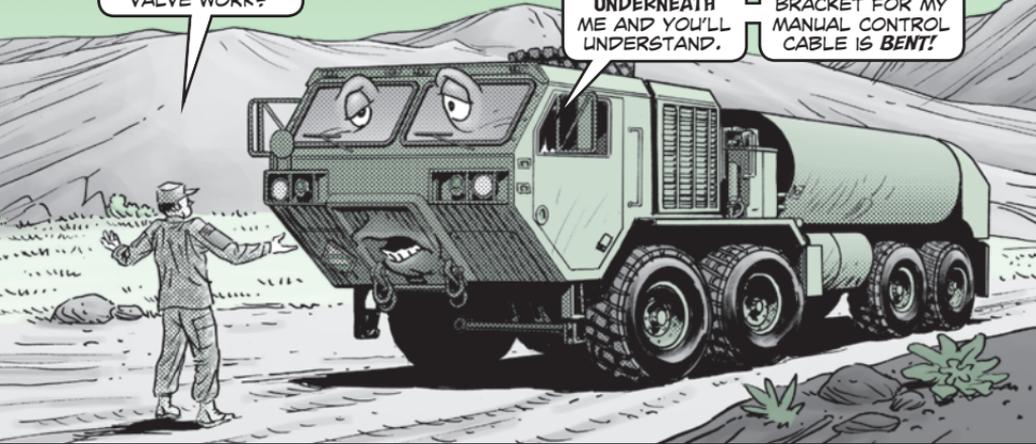
I DON'T GET IT.
WHY WON'T THE
MANUAL CONTROL
FOR YOUR VI
EMERGENCY
VALVE WORK?

CHECK
UNDERNEATH
ME AND YOU'LL
UNDERSTAND.

THE SUPPORT
BRACKET FOR MY
MANUAL CONTROL
CABLE IS **BENT!**

If the support bracket is bent, it's likely because the cable isn't properly adjusted. As the bracket bends, the cable binds even more. Pretty soon, you've got a cable that's damaged and an MC that won't pull at all.

If you find a bent support bracket, tell your mechanic. He'll replace the bracket, NSN 5340-01-618-5711, and readjust the cable to prevent future problems.

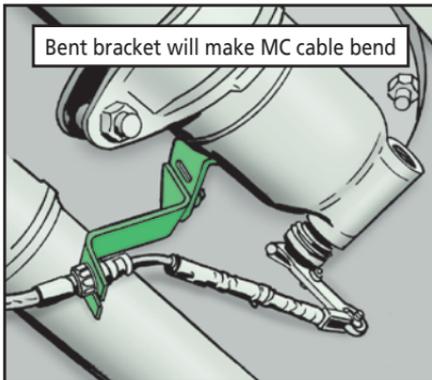
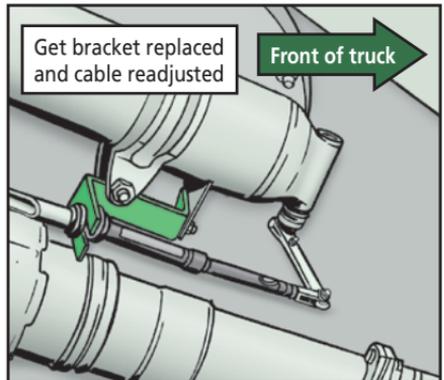
Having trouble pulling the manual control (MC) on your M978A4 HEMTT tanker's VI emergency valve, operators? Then get down on your hands and knees and take a close look at the MC cable's support bracket.
