STOP BENT STOP BAR DANGER!

We've discovered a problem with the M1148A1P2 load handling system (LHS) that units need to be on the lookout for: The stop bar for the right wheel roller bends out of position. If you try to lift a CONEX with a bent stop bar, the CONEX could slide to the left and maybe even slide completely off.

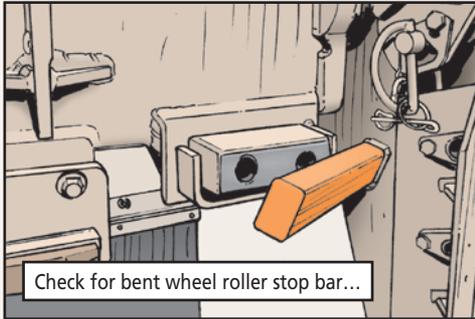
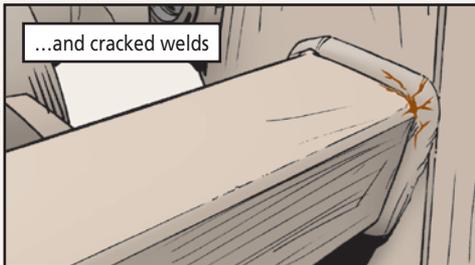
Before lifting with the M1148A1P2, check to see if either stop bar for the wheel rollers is bent. It's also a good idea to look for cracks in the welds.

If you spot any problems, report 'em. Don't lift *any* CONEXs until the stop bar is fixed or replaced.

- Before loading, clean the roller beds of any debris, particularly rocks.
- Use ground guides during loading to ensure that the containers or flatracks aren't dragged.
- Pay attention to the loading cautions in TM 9-2320-392-10-2, especially making sure the guide roller bed on each side of the truck is outside of the bottom of the container.
- Keep the proximity sensors and sensing plates clean and free of paint. If they're dirty, the M1148 won't operate in the automatic mode.
- Carefully do all the PMCS called out in the -10, particularly lubrication and cleaning of the truck and roller beds.
- Do not drag the containers or flatracks. They should be picked up as close to the LHS as possible.
