SHOW RESTRAINT WHEN CLOSING THE DOOR

Here at Ft Leonard Wood, MO, we're seeing a lot of driver's side restraint systems damaged on M1157A1P2 LTAS FMTVs.

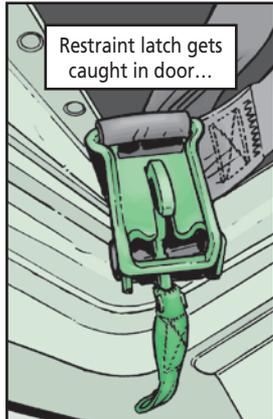
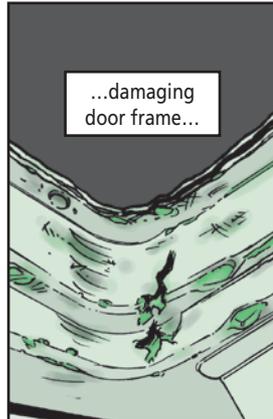
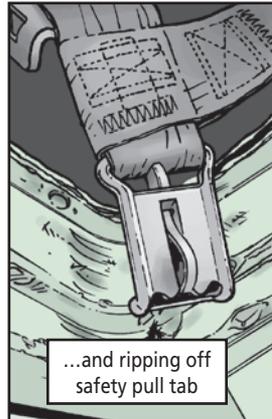
If the driver doesn't make sure the four-point seat belt is inside the cab before shutting the door, the belt's restraint latch gets slammed between the door and door jam. This not only damages the door and jam, but the heavy doors often ruin the safety pull tab (latch guard) on the restraint latch.

According to the before operations PMCS checks in TM 9-2320-333-10, any part of the restraint system that is missing or damaged makes the vehicle NMC.

A new restraint system, NSN 2540-01-528-1903, costs about \$260. But we've found a better solution. If the safety pull tab is the only part damaged, units can get a replacement from Mastercraft, Inc., for just \$12.95. Just order on a DD Form 1348-6 using PN 500976-443 and CAGE 3UKX4. That PN also includes the screw and nut to hold the pull tab in place.

Of course, the best fix would be for operators to make sure the vehicle's seat restraint is clear of the door before closing it.
