UH-60...

# OVERFILLING NOT A GOOD THING

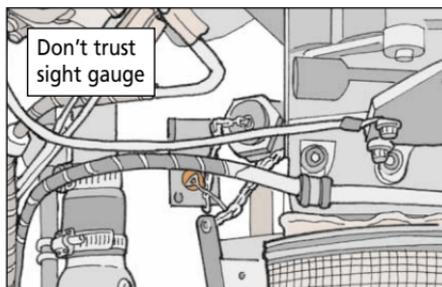
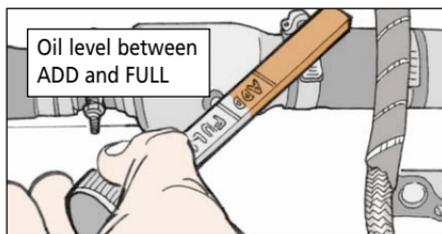
WHERE DID ALL THIS OIL COME FROM?

LOOKS LIKE *SOME-BODY* GOT HAPPY AND POURED TOO MUCH OIL IN MY APU!

If your Black Hawk's auxiliary power unit (APU) APU OIL TEMP HI warning light comes on and oil starts spewing out of the exhaust and onto the ramp, you may be overservicing the APU.

Too much oil is almost as bad as not enough oil in the sump. Too much oil in the APU can blow out power turbine seals and cause a fire.

The APU is not level since it is installed with a nose-high attitude, so it's easy to overfill.

Service the APU like it says in Para 1-3-9 of TM 1-1520-237-23. Add oil slowly until the level in the sump is between the ADD and FULL marks on the dipstick when the oil is cold. Don't use the sight gauge because it gives a slightly different reading. If the oil is between ADD and FULL, don't try to get it to the FULL mark.

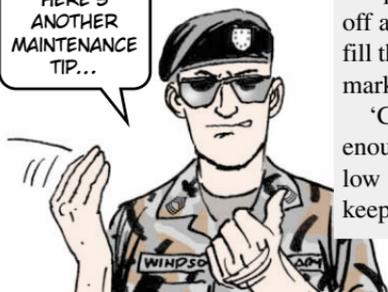
HERE'S ANOTHER MAINTENANCE TIP...

Keep in mind that the dipstick reading could be off a bit when servicing the APU. Play it safe and fill the APU to no more than  $\frac{1}{4}$ -in below the FULL mark. That prevents pouring more than you need.

'Course, if you're worried about not getting enough oil in the APU, don't. It won't start if a low oil pressure situation exists. Bottom line is, keep the oil between the lines.
