CHECK THE PAINT JOB

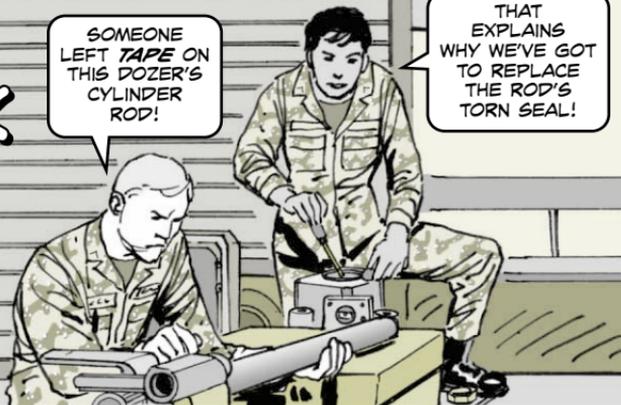
SOMEONE LEFT TAPE ON THIS DOZER'S CYLINDER ROD!

THAT EXPLAINS WHY WE'VE GOT TO REPLACE THE ROD'S TORN SEAL!

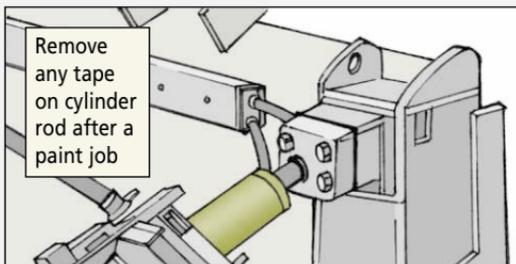
Cylinder Rods

Any tape left on the cylinder rods will scrape or cut the rod's seals when the rod is extended or retracted. A damaged seal leads to fluid leaks, which leads to NMC equipment.

If you see any tape on the rods, remove it before starting the vehicle.

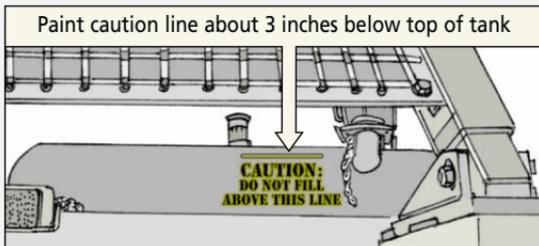
Fuel Fill Line Reminder

While walking around the vehicle, look at the back end of the dozer's fuel tank. Some paint shops spray over the fuel tank's fill line. Without that line, you no longer have a quick reminder to allow for fuel expansion.

If the line gets covered up, have your mechanic use black CARC paint to stencil a new fill line marking the bottom of the fill neck—about 3 inches below the top of the fuel tank.

Below the fill line stencil, paint CAUTION—DO NOT FILL ABOVE THIS LINE TO ALLOW FOR EXPANSION. The stencils are part of the No. 1 and No. 2 Common shop sets.
