HH-60L/UH-60A/L...

NO TAIL ROTOR HARDWARE MIX-UP THIS TIME!

# USE COLOR FOR BALANCE, TOO

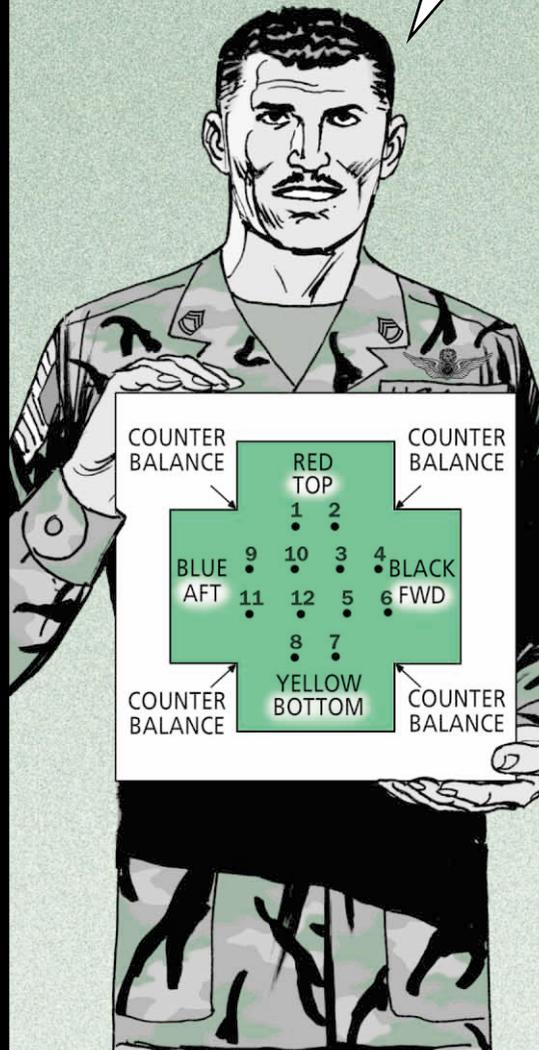
The instructions to make the tail rotor hardware display board do not allow for the rotation of the tail rotor which may happen while it is disassembled.

If the tail rotor blades being removed are to be installed in the same gear box, and the color bands have worn off, use a grease pencil and put index marks on blades, retention plates, pitch control rods, and pitch beam so they are reinstalled in the same clockwise and inboard/outboard positions to minimize rebalancing of the tail rotor.

To maintain proper tail rotor balance, it's also important to mark the board with red, yellow, blue and black labels as shown on the retention plate. This will further reduce hardware mixup because if the rotor turns, it ensures the hardware will be installed in the same position from which it was removed.

It's also important that the pitch beam, inboard retention plate and outboard retention plate and each pitch control rod are marked with the correct color, too.

THE POTENTIAL FOR TAIL ROTOR ERROR BY *NOT* SHOWING THE COLORS COINCIDING WITH THE TOP, BOTTOM, AFT, AND FWD ON THE BOARD IS IMPORTANT.
