LUBE HELPS "STICKY" PIN

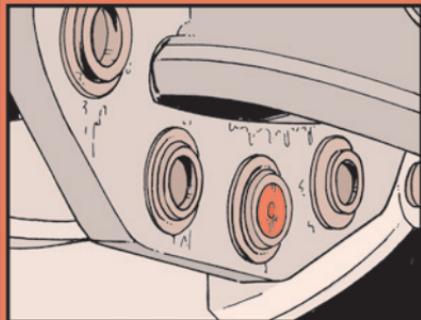
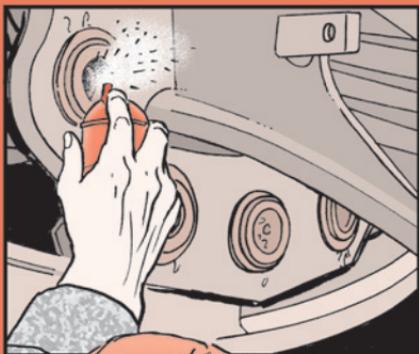
POSITIONING THE GRADER BLADE IS "STICKY" BUSINESS WHEN THE VEHICLE SITS TOO LONG WITHOUT EXERCISE.

NO EXERCISE MEANS THE GRADER'S CENTERSHIFT PIN RUSTS IN PLACE.

THEN YOU CAN'T MOVE THE PIN IN AND OUT OF THE CENTERSHIFT HOLE TO POSITION THE BLADE.

- First, exercise the grader by pulling the centershift pin out of the hole at least once a month. That way rust won't "freeze" the pin in place.

- Second, spray the hole and pin with corrosion preventive compound. NSN 8030-00-938-1947 gets a 16-oz can.
