# CORRECTING PROPERTY BOOK MISTAKES

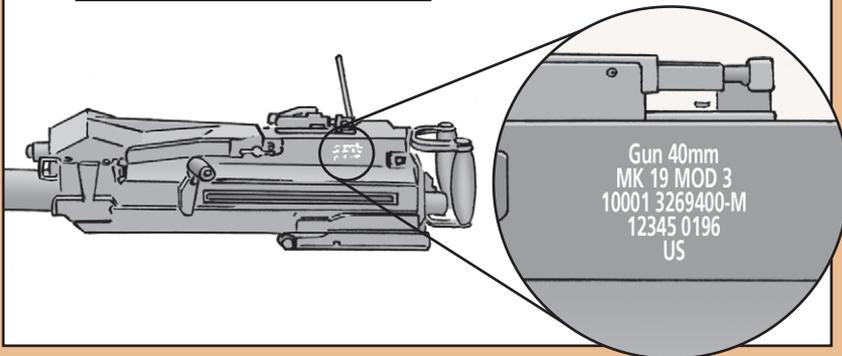
Serial number is on left side of receiver

The usual mistake is adding the date stamp or extra zeroes to the serial number.

Here's an example of how to correctly read the ID stamp on the left side of the receiver.

- Line 1: Gun 40mm
- Line 2: MK 19 MOD 3
- Line 3: 10001 (CAGE code) and 3269400-M (part number)
- Line 4: 12345 (four or five digit serial number) and 0196 (month and year of manufacture)
- Line 5: US  
The serial number is 12345, not 123450196.

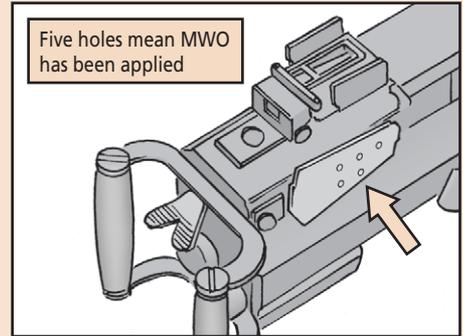
Another common property book mistake is not changing the MK 19's NSN after MWO 9-1010-230-50-1 has been applied. The NSN should be changed from 1010-01-126-9063 to 1010-01-490-9697. LIN M92362 stays the same, but "-M" must be added to the part number.

How do you tell if the MWO has been applied? The MK 19 will have five holes drilled on the right side of the receiver, a new sight mounting bracket, new firing pin, new firing pin sear, a two-piece cocking lever, and adjustable secondary drive assembly. If your MK 19s haven't been modified, notify your MWO officer. The MWO should have been completed by June 07.
