FLAREBACKS CAN BE AVOIDED

THERE'S NOTHING THAT'LL RUIN YOUR DAY FASTER THAN A **FLAREBACK** IN YOUR M1-SERIES TANK.

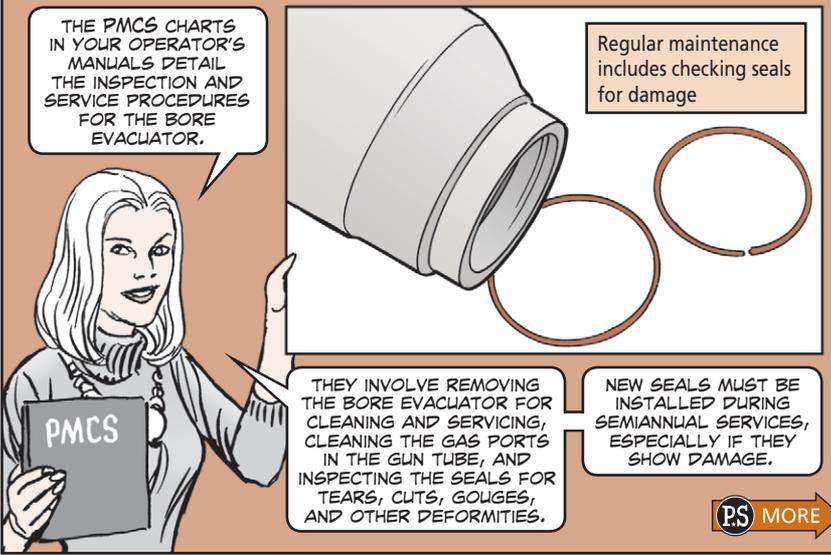
Regular maintenance includes checking seals for damage

THEY INVOLVE REMOVING THE BORE EVACUATOR FOR CLEANING AND SERVICING, CLEANING THE GAS PORTS IN THE GUN TUBE, AND INSPECTING THE SEALS FOR TEARS, CUTS, GOUGES, AND OTHER DEFORMITIES.

NEW SEALS MUST BE INSTALLED DURING SEMIANNUAL SERVICES, ESPECIALLY IF THEY SHOW DAMAGE.

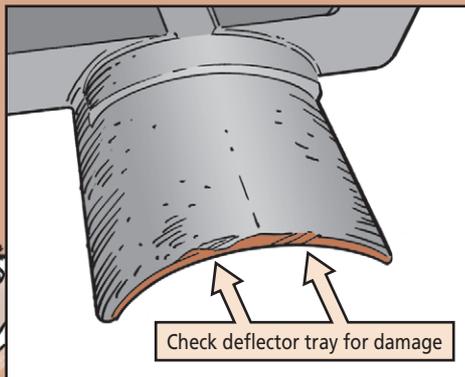
IF THE DEFLECTOR TRAY IS MISALIGNED, THE EJECTED STUB BASE HITS THE FRONT EDGE OF THE TRAY.

EYEBALL THE DEFLECTOR TRAY FOR DENTS, NICKS, OR GOUGES, ESPECIALLY AT THE FRONT LEADING EDGE.

A MISALIGNED STUB BASE DEFLECTOR TRAY CAN ALSO DAMAGE THE ROUND DURING LOADING. THE DAMAGE ISN'T USUALLY NOTICED SINCE IT HAPPENS WHEN THE ROUND IS CHAMBERED.

IF YOU FIND DAMAGE TO THE DEFLECTOR TRAY OR EXTRACTORS, NOTIFY YOUR MECHANIC IMMEDIATELY.

THEY MUST BE REPAIRED OR REPLACED BEFORE THE TANK CAN FIRE LIVE ROUNDS AGAIN.

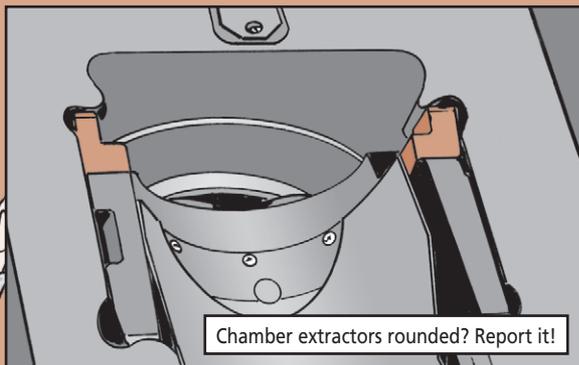
MAKE SURE YOU INSPECT THE CHAMBER EXTRACTORS FOR DAMAGE, TOO.

AN EXTRACTOR WITH ROUNDED OR DAMAGED EDGES HAS A HARD TIME EXTRACTING THE STUB BASE.

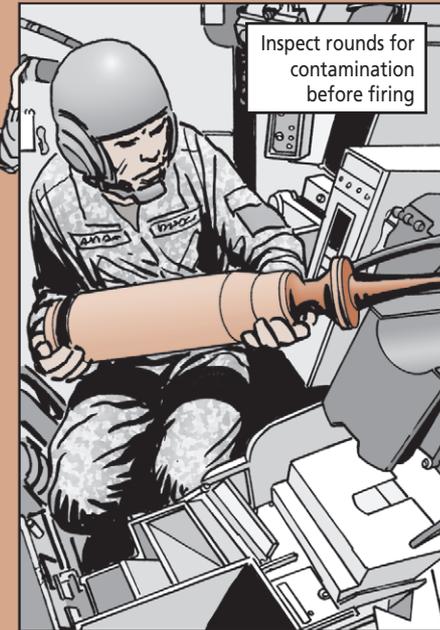
Inspecting the rounds themselves is also a critical step in flareback prevention. Rounds that are contaminated with water, oil, or other substances might not burn completely. The residue left behind could ignite any gases not expelled by the bore evacuator.

Inspect rounds for contamination before firing

CLOSELY INSPECT YOUR ROUNDS FOR DAMAGE OR CONTAMINATION THAT COULD LEAD TO FLAREBACK.
