# Heads Up On IHADSS

## Lift and Shift

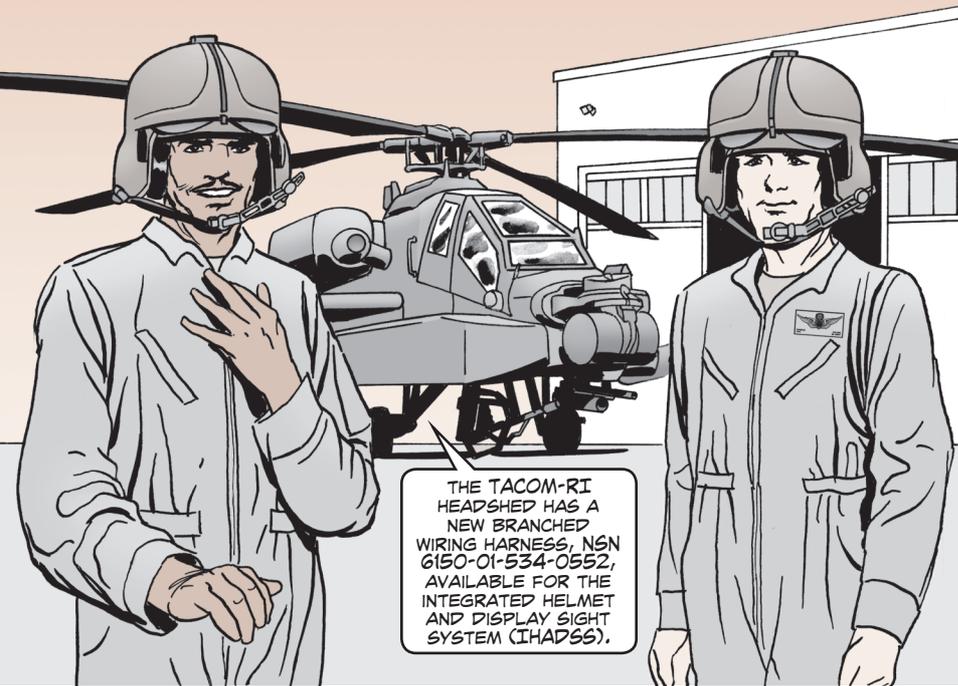
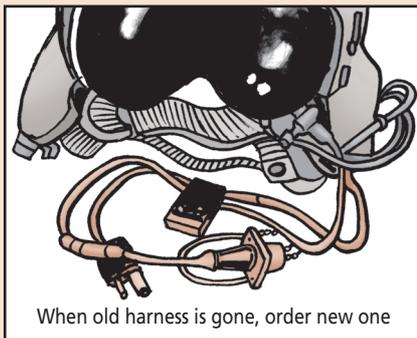
This new harness will replace the legacy branched wiring harness, NSN 6150-01-186-8601, by attrition. Continue to request the legacy harness. When stocks are depleted, you will automatically receive the new harness.

ALSE repairers should use care when installing the sensor alignment scope on aircraft with the new wiring. That's because the electronic component assembly has less clearance around the sensor scope mounting nut-plate. Over-tightening the sensor scope screw could damage the circuit card housing and the card.

So, eyeball TACOM MAM 09-002, *Helmet Unit, Branched Wiring Harness*, for the disassembly and assembly procedures. The MAM also lists materials and parts.

The new wiring harness info includes procedures for replacing defective parts. Replacing the harness is a field-level repair and can be tested with the helmet operational level tester (HOLT), NSN 4931-01-534-1228. Check out the manufacturer's user's guide that comes with the shipment.

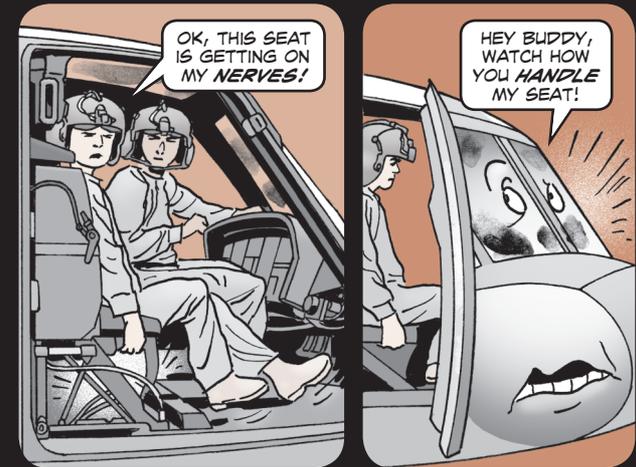
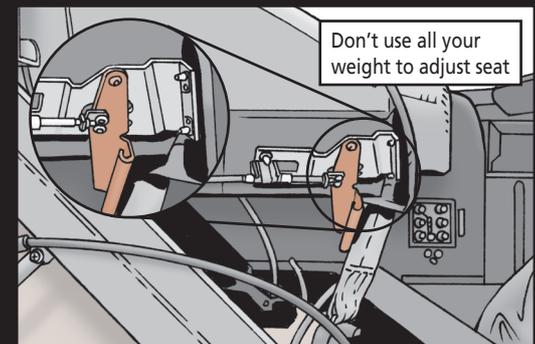
Your Black Hawk pilot and co-pilot seats are not designed to allow the full force of your body weight to free fall into the seat.

Plopping into the seat, or slamming onto or bouncing on the seat to force adjustment can break or bend the vertical bracket under the seat. If that happens, your bird is NMC and the mission never gets off the ground.

When adjusting the seat it is a good practice to sit in the seat normally. Then move your body around and lift your body to adjust the seat.
