OH-58D...

THE RIGHT AMOUNT OF OIL AND GREASE

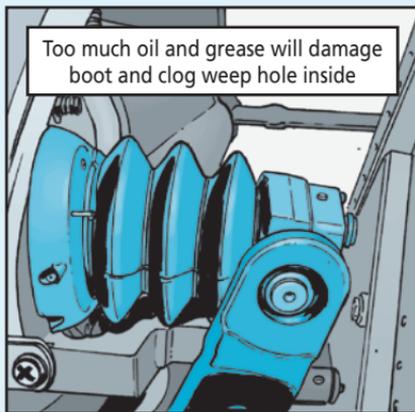
Too much or too little oil and grease are not good for your Kiowa Warrior's tail rotor gearbox and its inner bearings.

If you add too much, the excess oil runs down the output shaft during operation and gets into the trunion and its Teflon® bearings.

When you add too much grease to the pitch control mechanism inner bearings, the extra grease fills up the boot, and pumps it into the gearbox, contaminating it.

Too much oil and grease is a problem, but not lubing is just as bad. Don't forget to grease the pitch change inner bearings on the tail rotor gearbox. If you constantly forget, the trunion bearings will heat up and eventually allow oil from the gearbox to leak into the boot area that covers the rod.

Inside the boot there is a weep hole that needs proper cleaning. The weep hole allows for expansion and contraction of the boot. If the hole gets clogged with grease, air cannot move in and out of the boot. The boot can't collapse or expand, so it tears and deteriorates. That will affect the directional control pedals when flying your aircraft.

Don't go overboard and overfill the tail rotor gearbox or overgrease the bearing inside the pitch control mechanism. Do only what TM 1-1520-248-23 says. Don't add "just a bit more" for good measure because that leads to a messy cleanup.

As you add oil to the gearbox, allow a few seconds for the oil to stabilize before you read the site gage. That way you won't add too much.

So, when dealing with oil and grease, just keep it simple. Follow the TM and don't doctor up maintenance.
