# TARGETING TIPS FOR ACCURACY

# THE RIGHT MWO FOR YOUR BRADLEY

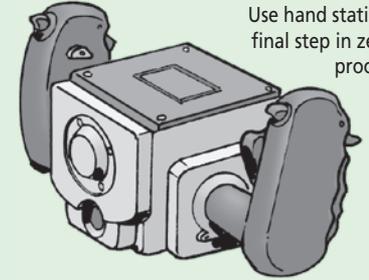
The problem is that crews use the crank instead of the hand station to do that last step. The M242 isn't really zeroed as a result. All they need to remember is to use the hand station for the final step to get it right.

Use hand station for final step in zeroing procedure

Crews can find the correct procedure in Para B-77 in FM 3-20-1, *HBC Gunnery Manual*, which explains how to zero the Improved Bradley Acquisition System (IBAS) to the M242.
