M1-Series Tanks...

BEAT BACK FLAREBACKS

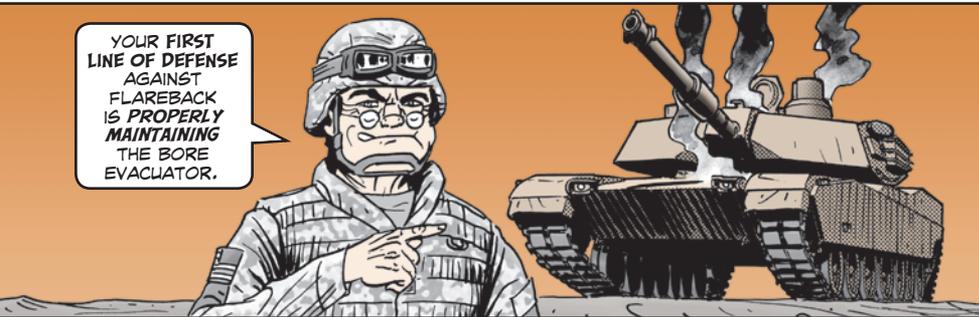
They include removing the bore evacuator for cleaning and servicing, cleaning the gas ports in the gun tube, and inspecting the bore evacuator and seals for tears, cuts, gouges and other deformities. New seals must be installed during semiannual services, even if they show no damage.

The PMCS charts in your operator’s manuals detail the inspection and service procedures for the bore evacuator.

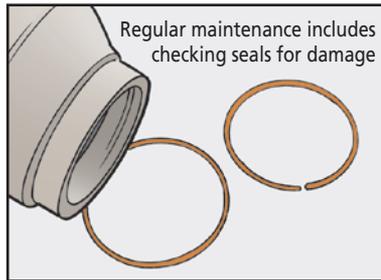
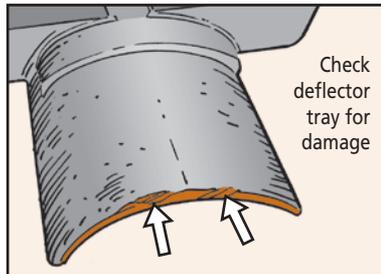
You need an open breech to allow fresh air to be drawn into the gun tube. If the stub base won’t fully eject from the chamber after firing, there’s a problem. The usual cause is a faulty stub base deflector tray or damaged chamber extractors.

If the deflector tray is misaligned, the ejected stub base hits the front edge of the tray. Check the deflector tray closely for dents, nicks or gouges, especially at the front leading edge.

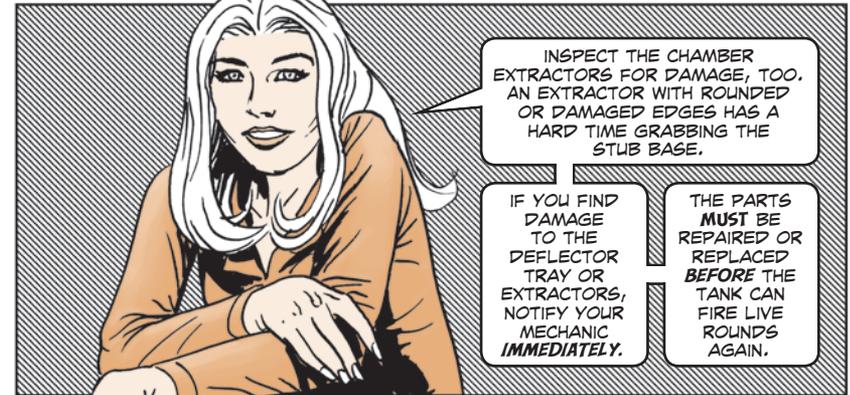
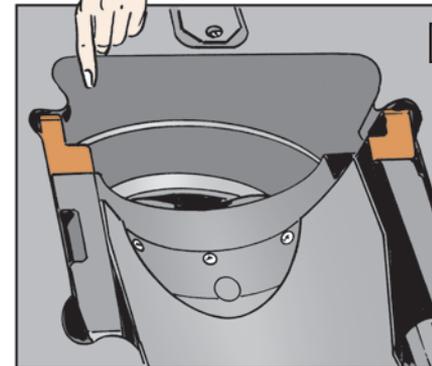
A misaligned or damaged stub base deflector tray can also damage the round during loading. The damage isn’t usually noticed since it happens when the round is chambered.

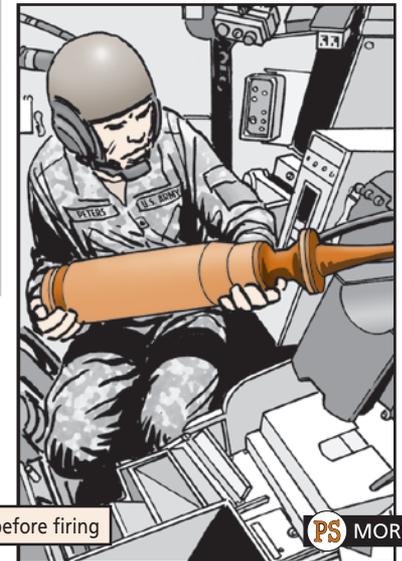
Inspecting the rounds themselves is also a critical step in flareback prevention. Rounds that are contaminated with water, oil or other substances might not burn completely. The residue left behind could ignite any gases not expelled by the bore evacuator.

Inspect rounds for contamination before firing

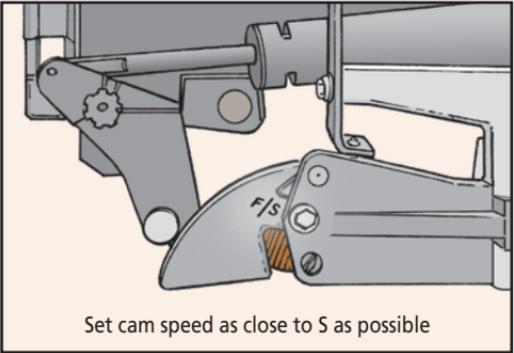
However, if the cam setting is too slow, the stub base won't eject properly and the bore evacuator will start to discharge before the breech opens.

The best way to reduce flareback during operation is to set the operating cam speed to the **S** position. The initial starting position should be one click past the **S** position to make sure the cam is fully engaged.

You'll find instructions for setting the cam based on temperature and operating conditions in WP 0460 of TM 9-2350-264-10-3 (Sep 11, w/Ch 3, Jan 15) and in WP 0552 of TM 9-2350-388-10-3 (Dec 12).
