# Mark Down These MK 19 Tips

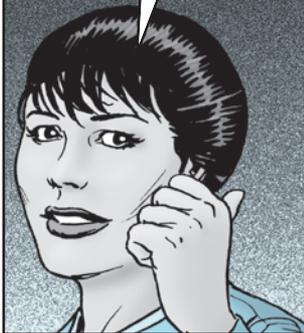
**Units don't have the adjusting tool for the secondary drive lever and they don't know how to use it.** This can make the MK 19 dangerous to fire. PS should repeat the procedure for using the tool.

NO PROBLEM, DAVID. UNITS CAN ORDER THE TOOL WITH NSN 1005-01-467-9435. HERE'S HOW TO USE IT...

1. Make sure the MK 19 is cleared and the bolt is forward.
2. Open the top cover assembly.
3. Remove the alignment guide and ogive plunger assembly.

4. Place the feed slide adjustment tool into the feeder base between the round positioning block and primary pawl with the rear of the tool aligned with the ammo link slot.
